Status of Residential Canal Benthic Habitats in the Florida Keys and the Effectiveness of Remediation Technologies Project Report

Prepared for the Water Quality Protection Program, Florida Keys National Marine Sanctuary
& The Village of Islamorada, Monroe County, Florida

Jason L. Howard, Sara S. Wilson, Christian C. Lopes, James W. Fourqurean

November 2018

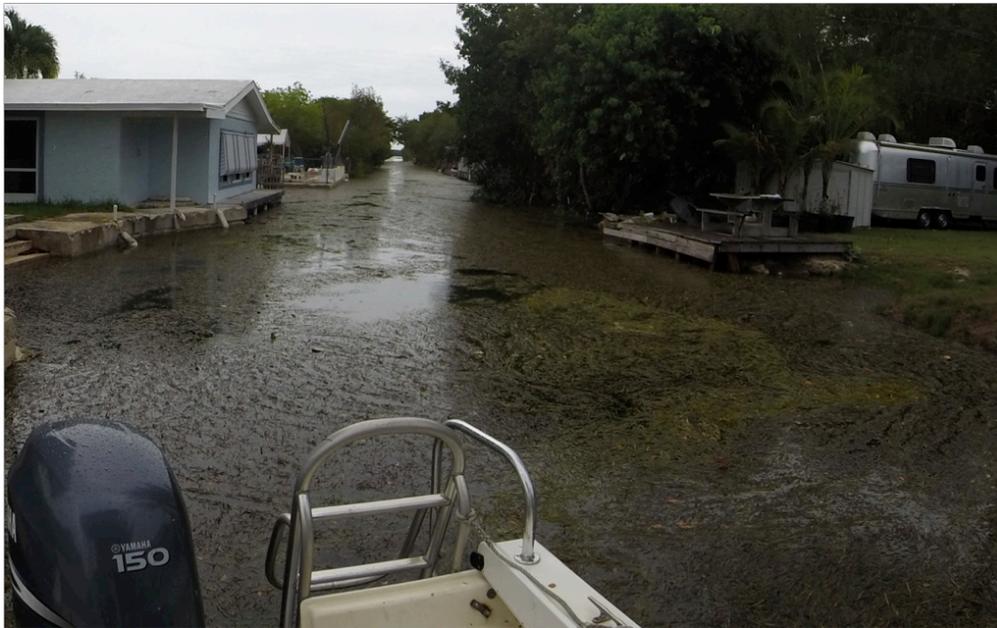
Figure 1.1: Seagrass wrack blown into Canal 263 floats on the surface before it sinks to further impair and accumulate in the bottom waters.

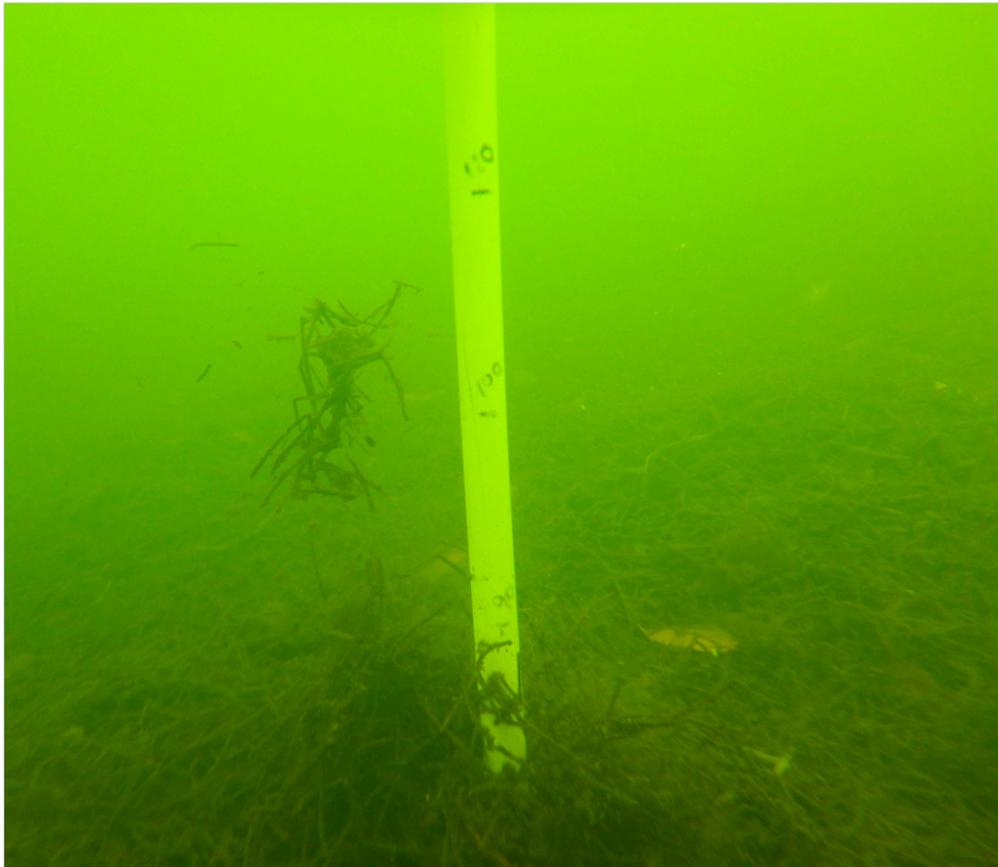
Seagrass wrack and other organic material is not completely decomposed, and the material remaining can create a fine, low density muck that accumulates over time, and in some cases can become several meters thick (Fig 1.2). Seagrass and algae found in South Florida are adapted to the sandy, carbonate sediments of the Florida Keys, though are poorly suited for growth in the low-density, unconsolidated organic material found in impaired canals.

Figure 1.2: Seagrass wrack and impaired water accumulating inside a canal. Over 80 cm of lightweight organic material has settled within this canal on eastern Big Pine Key. The sediment surface consists of dead plant material rather than sand, making it unsuitable for plant growth and as a habitat for benthic animals.
