# Environmental Canal Restoration, Effects on Plants, Animals and Sediments

Jason Howard, Sara Wilson, James Fourqurean  
Marine Education And Research Initiative, Florida International University  
WGPP meeting, April 18

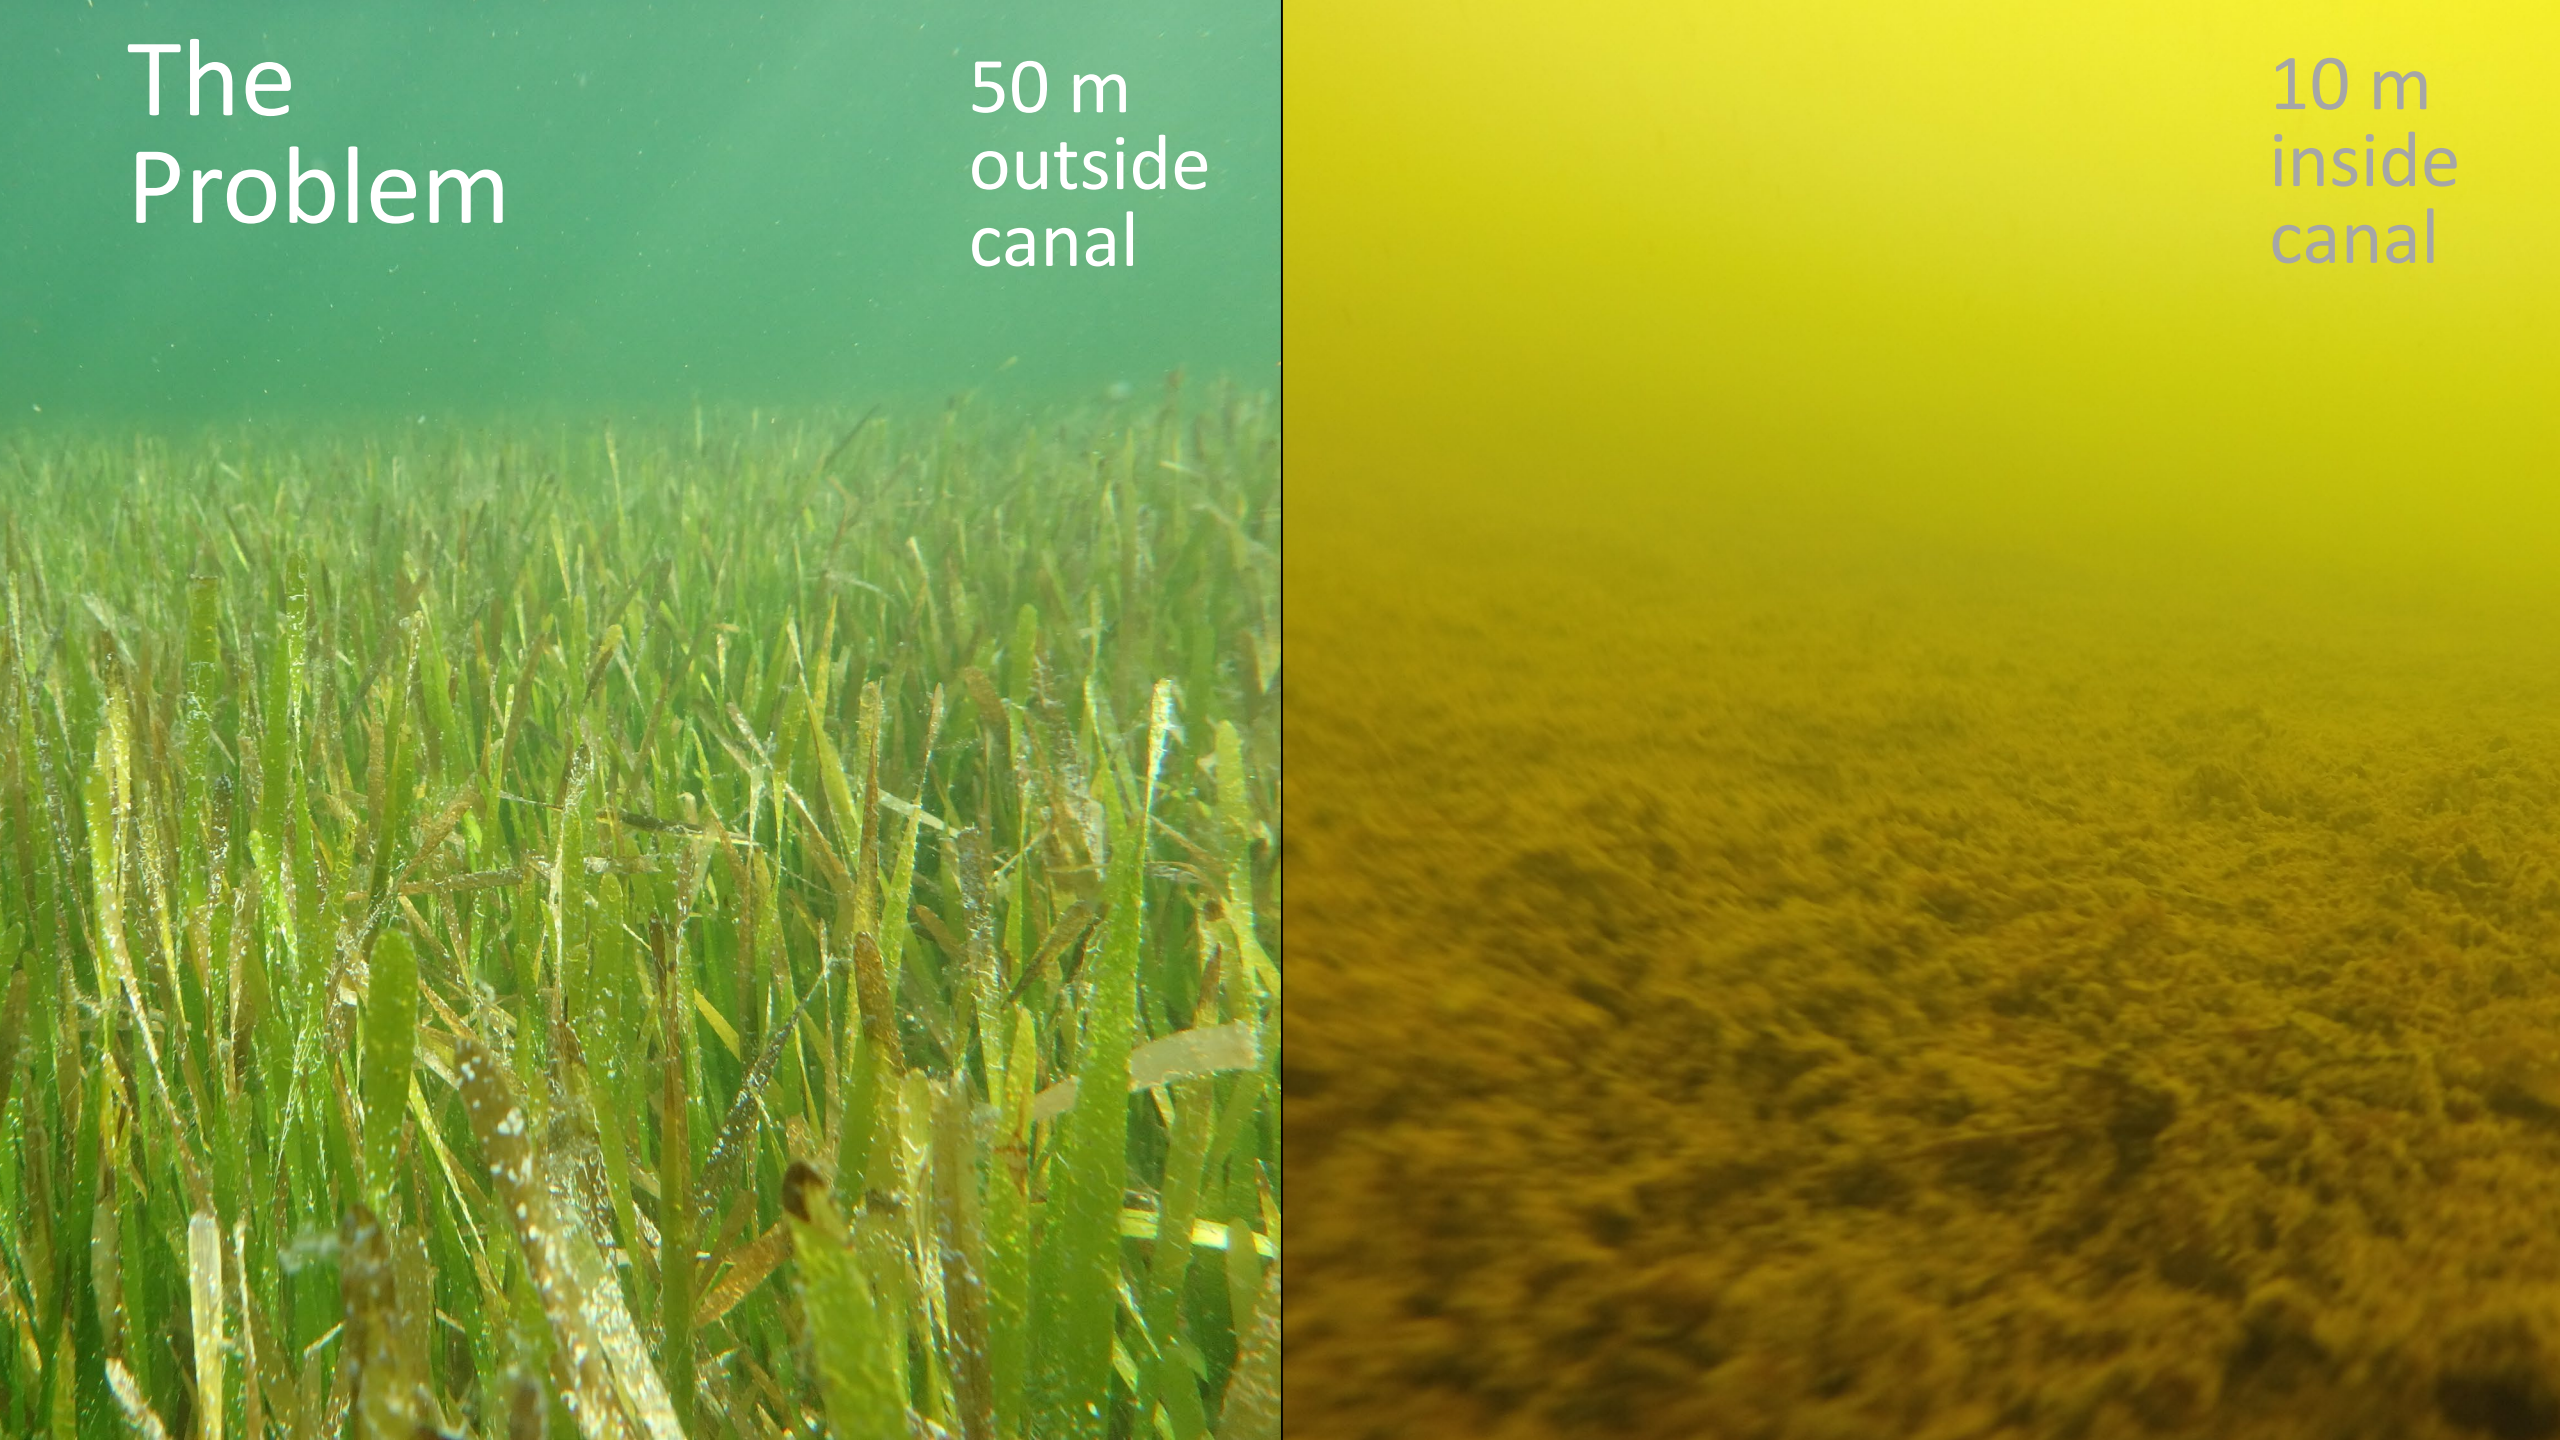
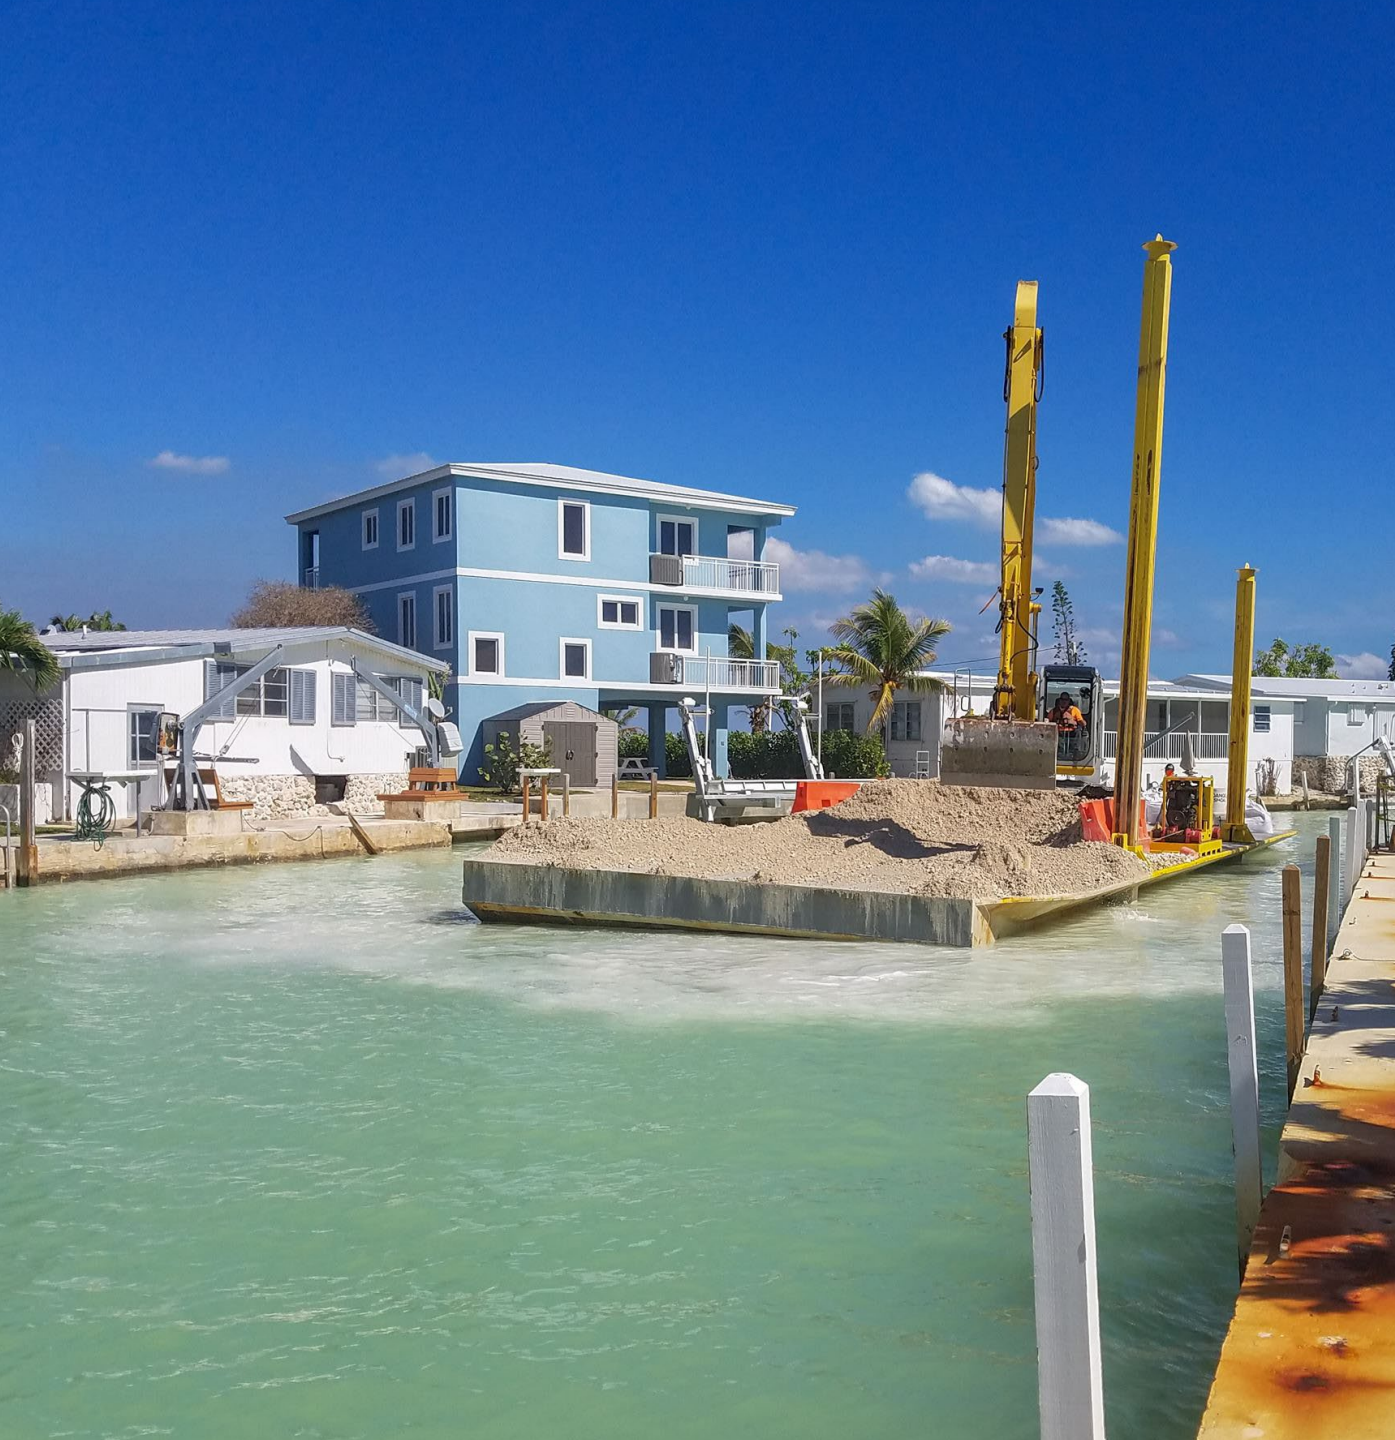
# The Problem

50 m  
outside  
canal

10 m  
inside  
canal

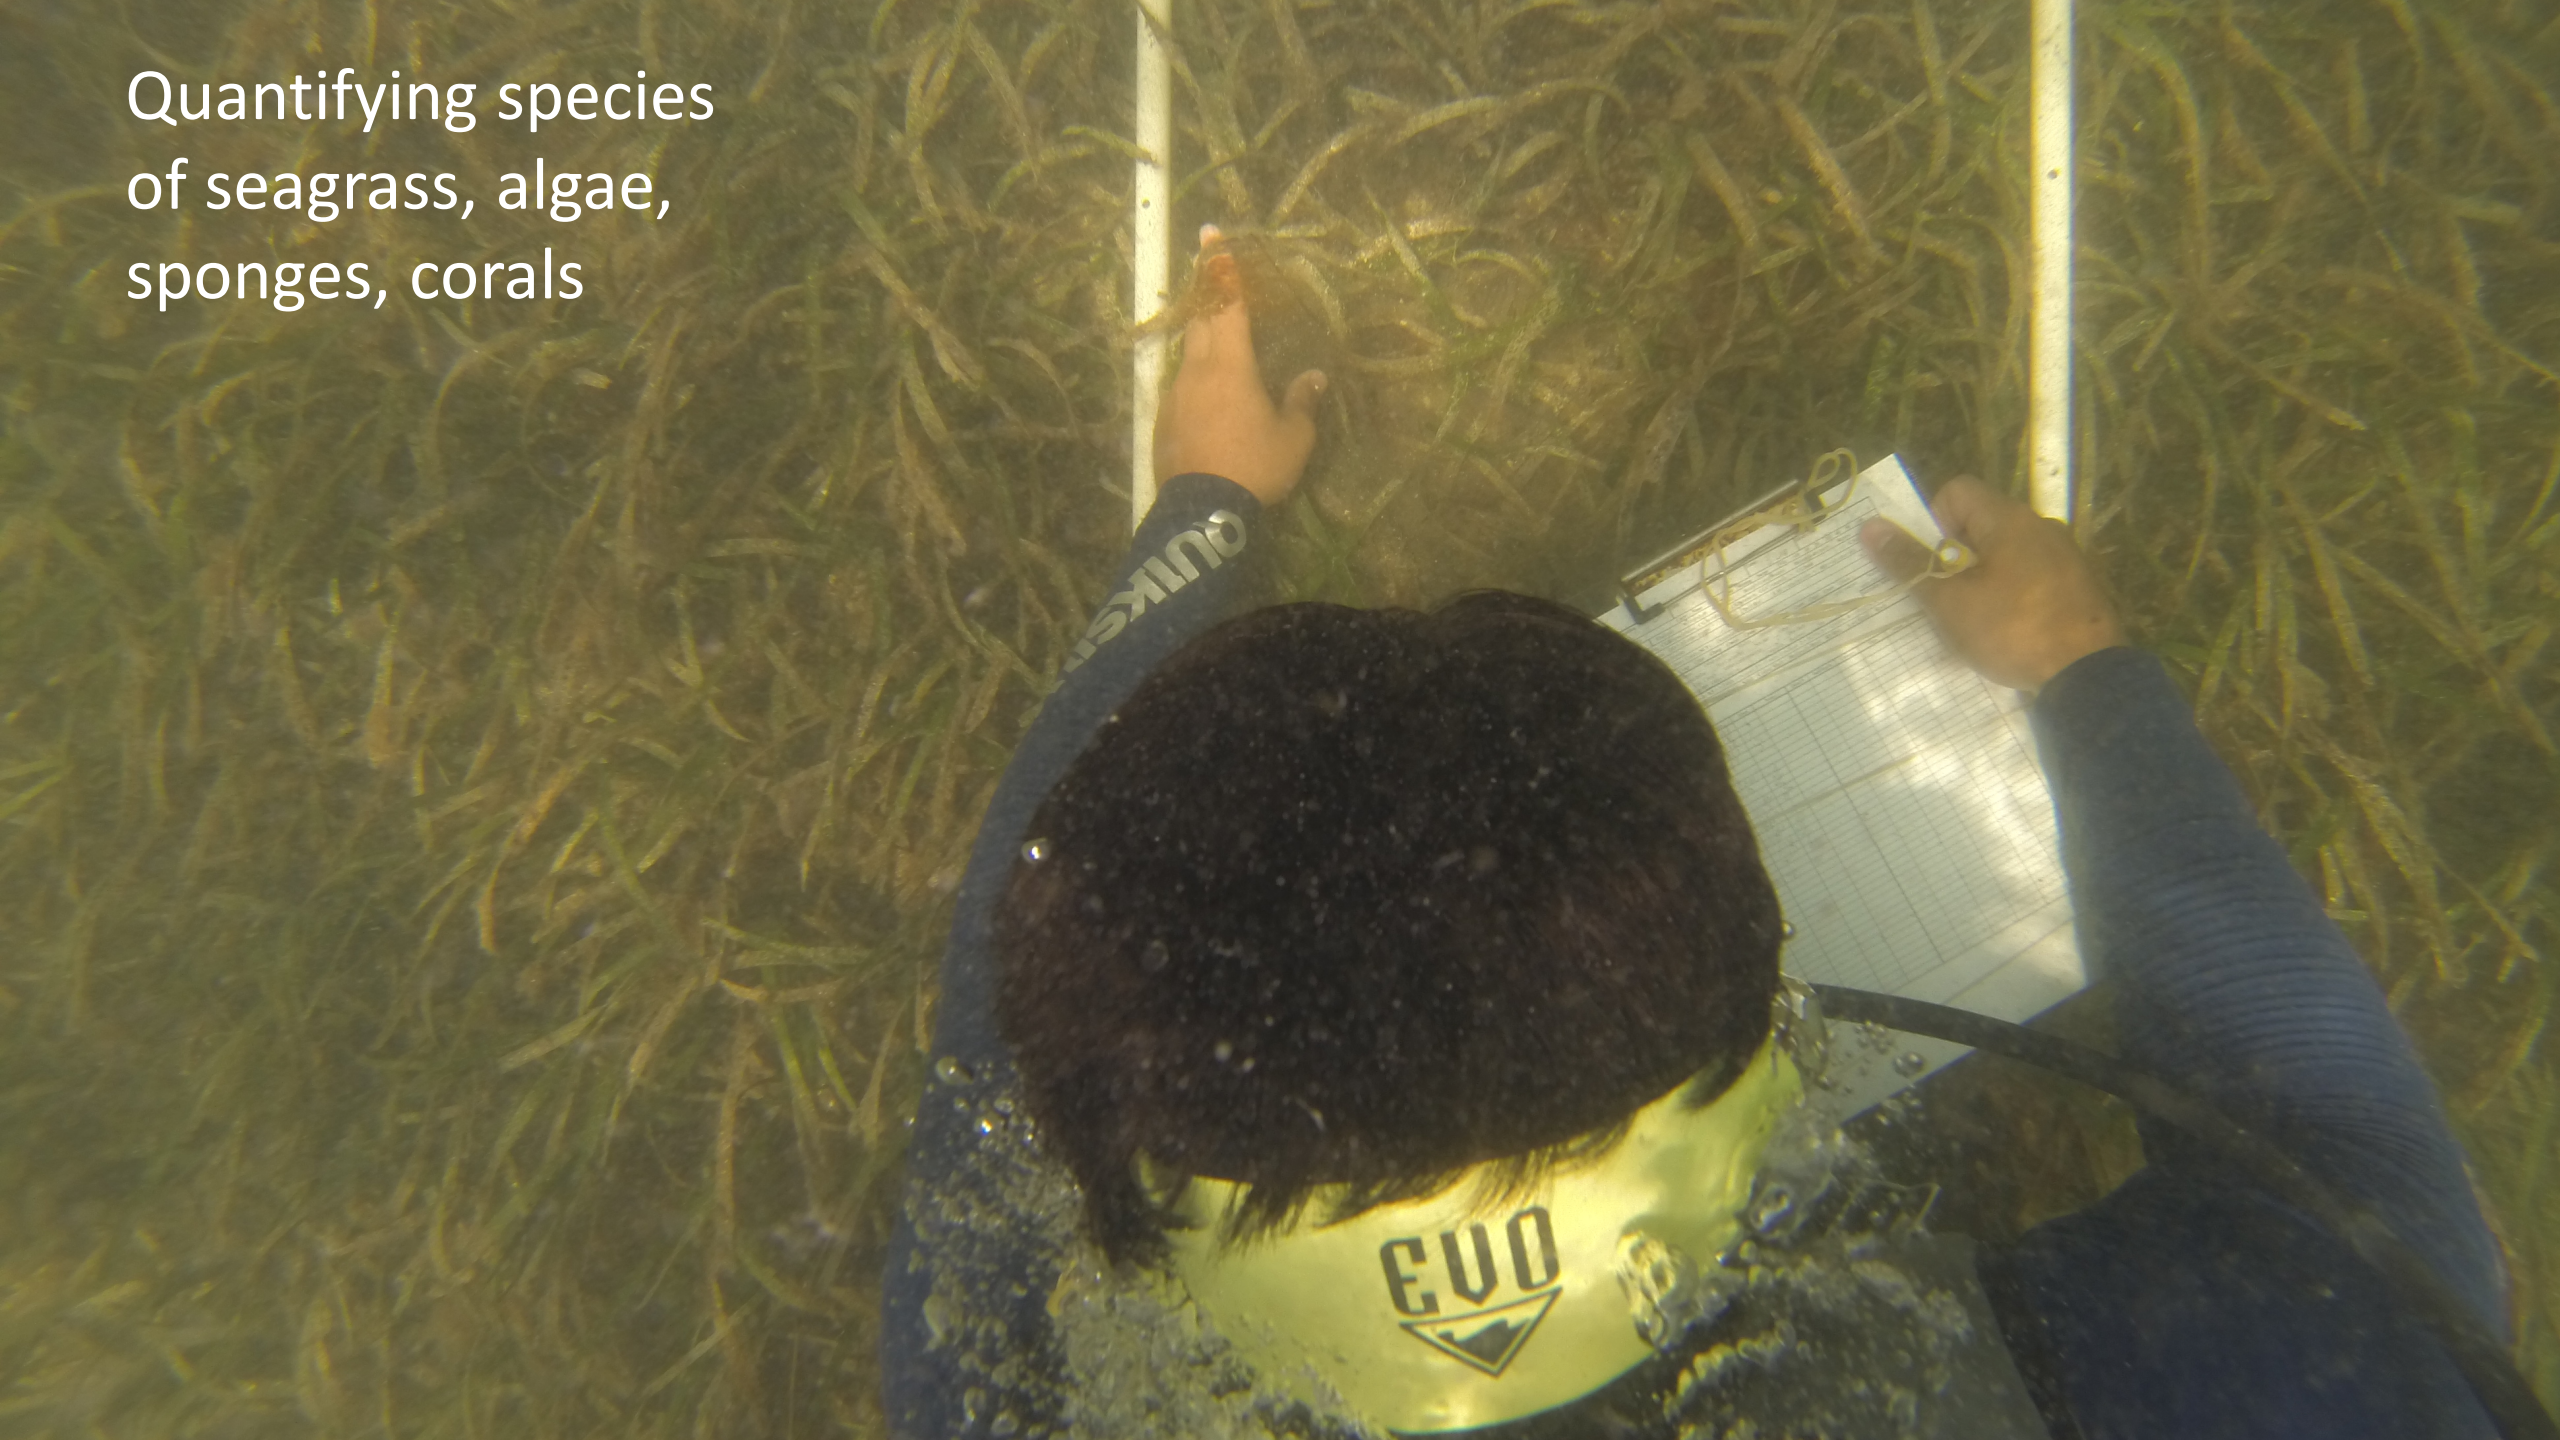
# Sampling Design

50cm x 50cm  
sites for  
benthic  
coverage

10cm x 10cm  
randomly  
placed for  
canal wall  
coverage

Seagrass leaf  
sample for  
chemical  
analysis

25 Canals  
Sampled 3 x yr<sup>-1</sup>

Quantifying species  
of seagrass, algae,  
sponges, corals

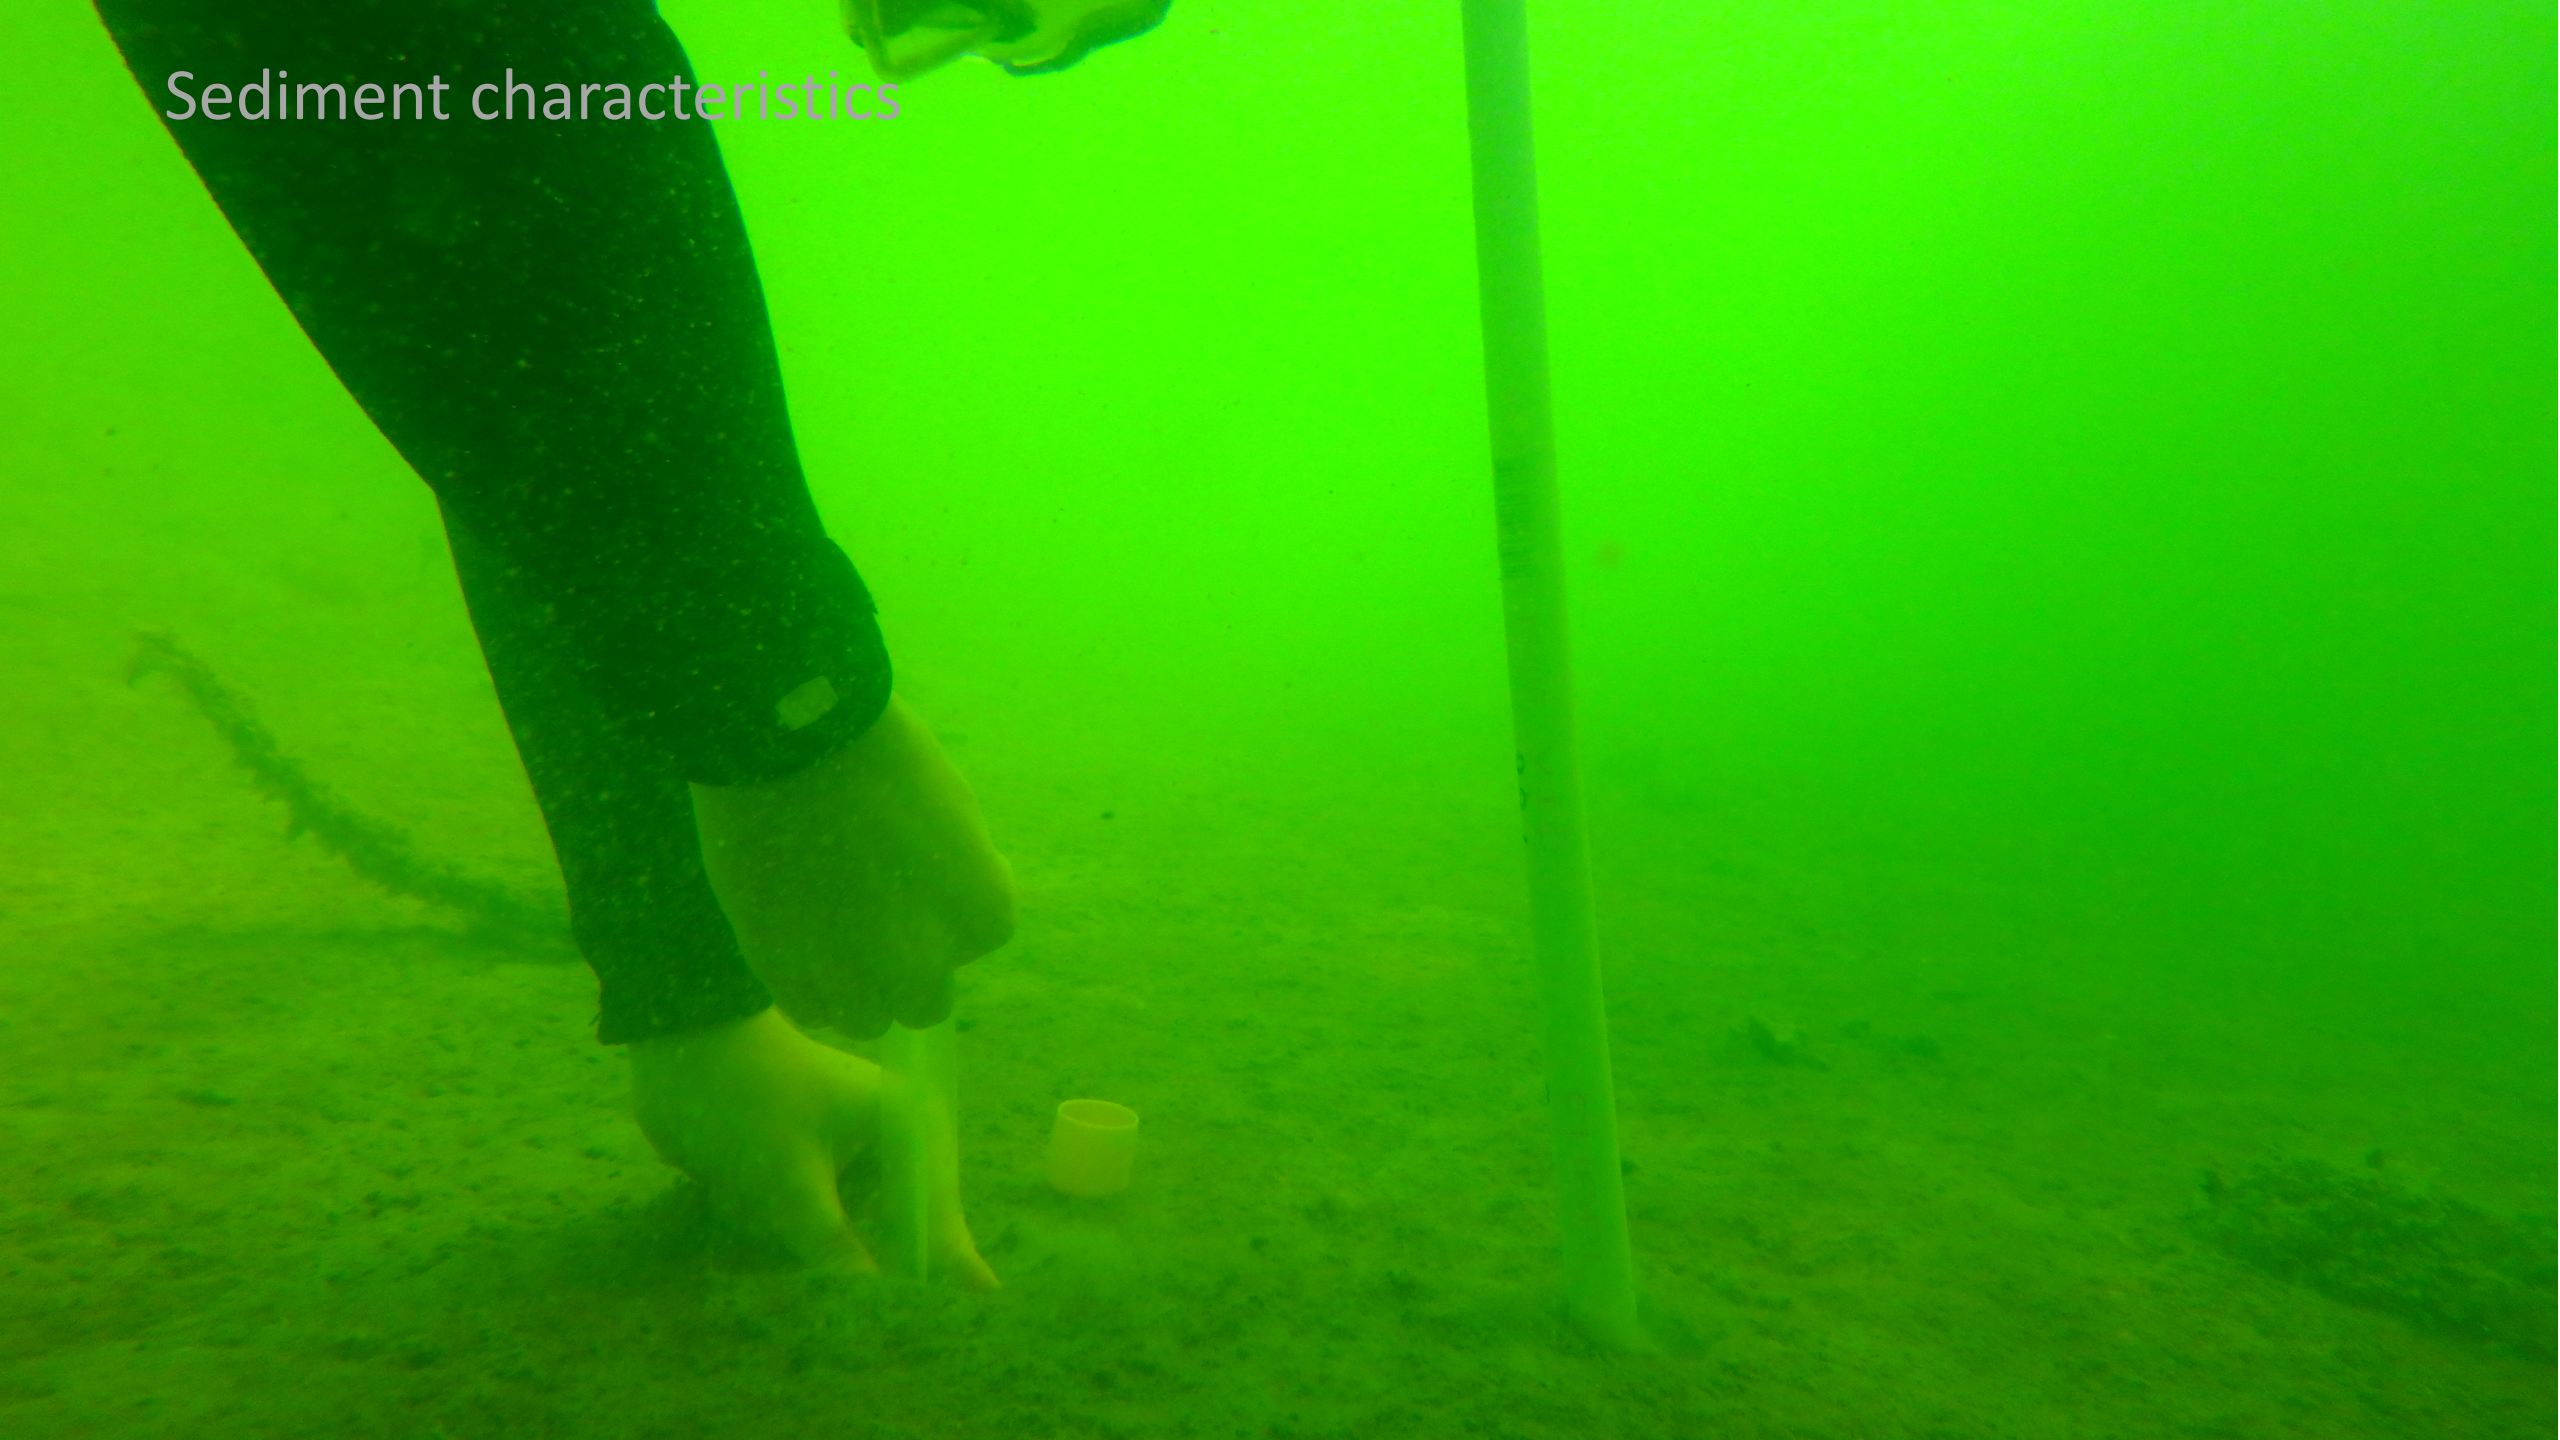
## Sediment characteristics

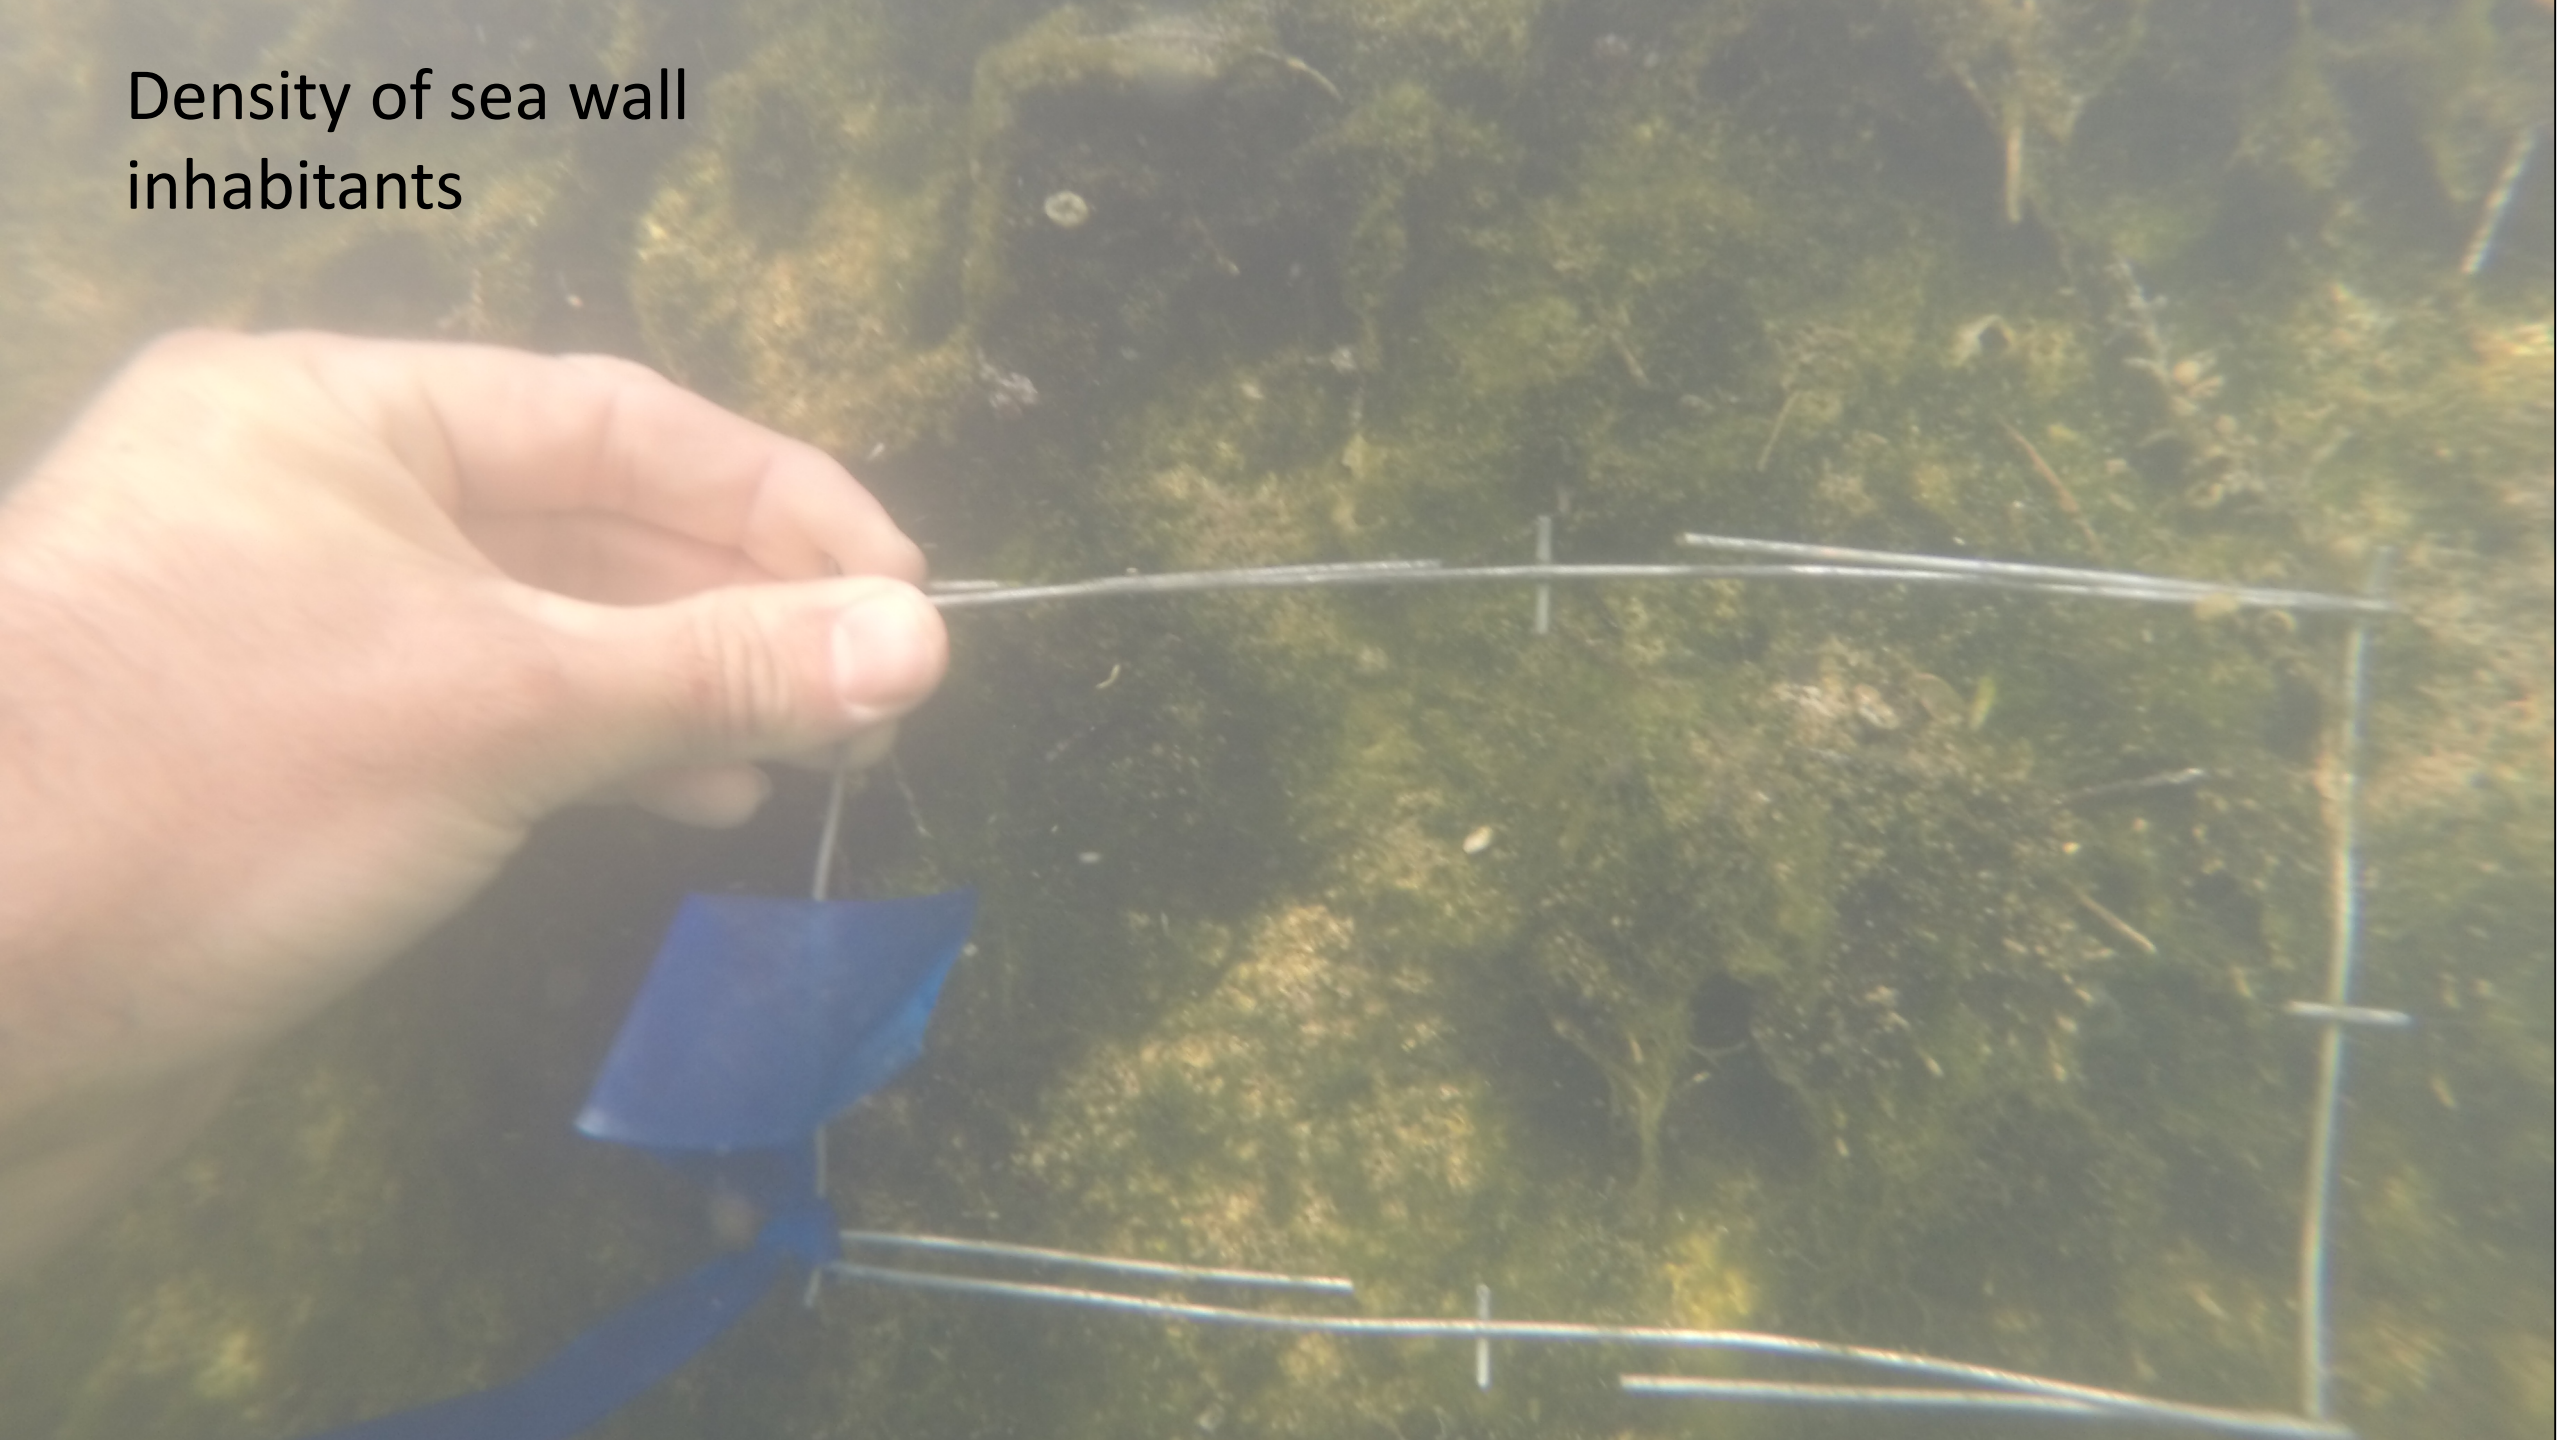
Density of sea wall  
inhabitants

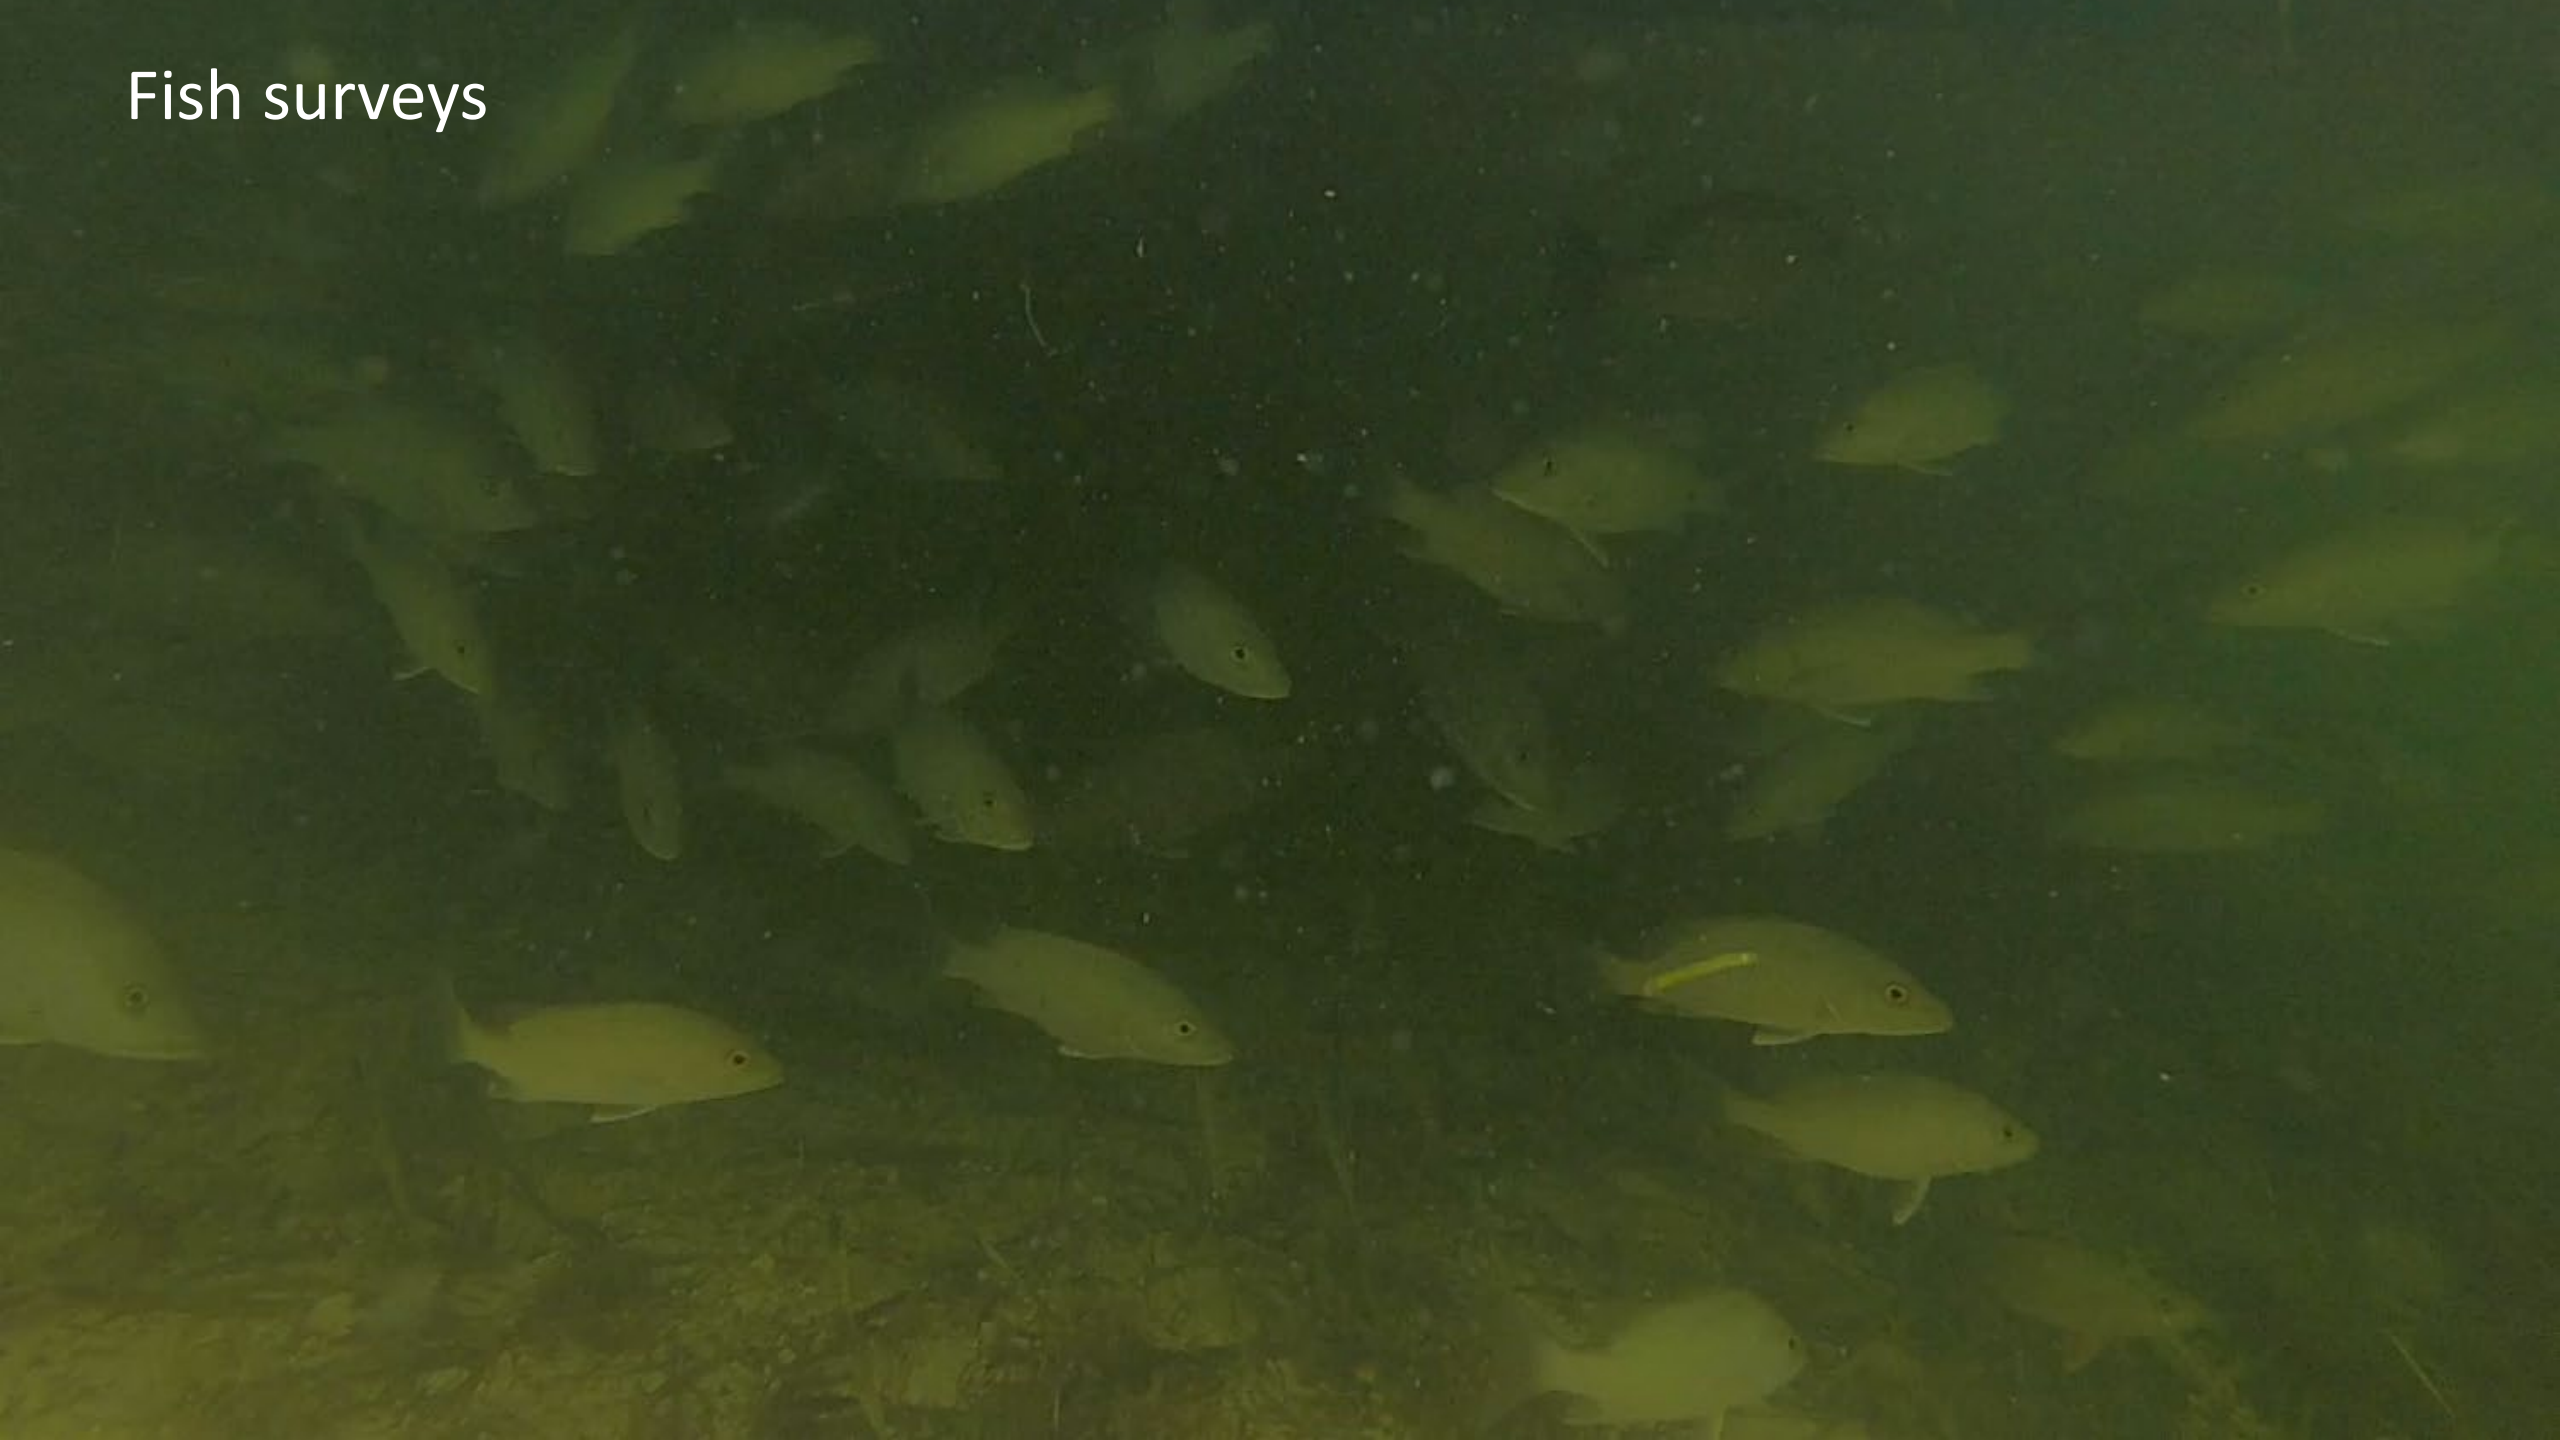
# Fish surveys

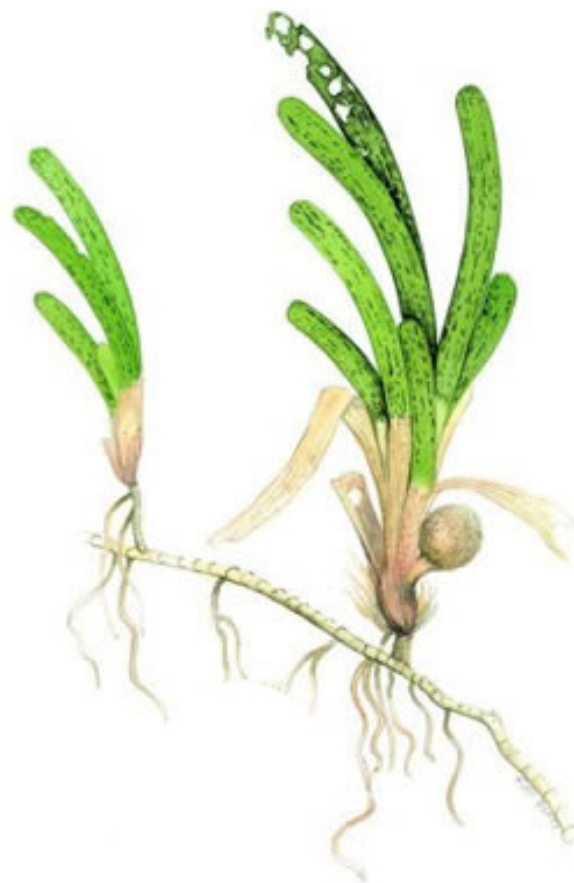
# Seagrass tissue chemistry

C:N:P

$^{13}\text{C}/^{12}\text{C}$

$^{15}\text{N}/^{14}\text{N}$

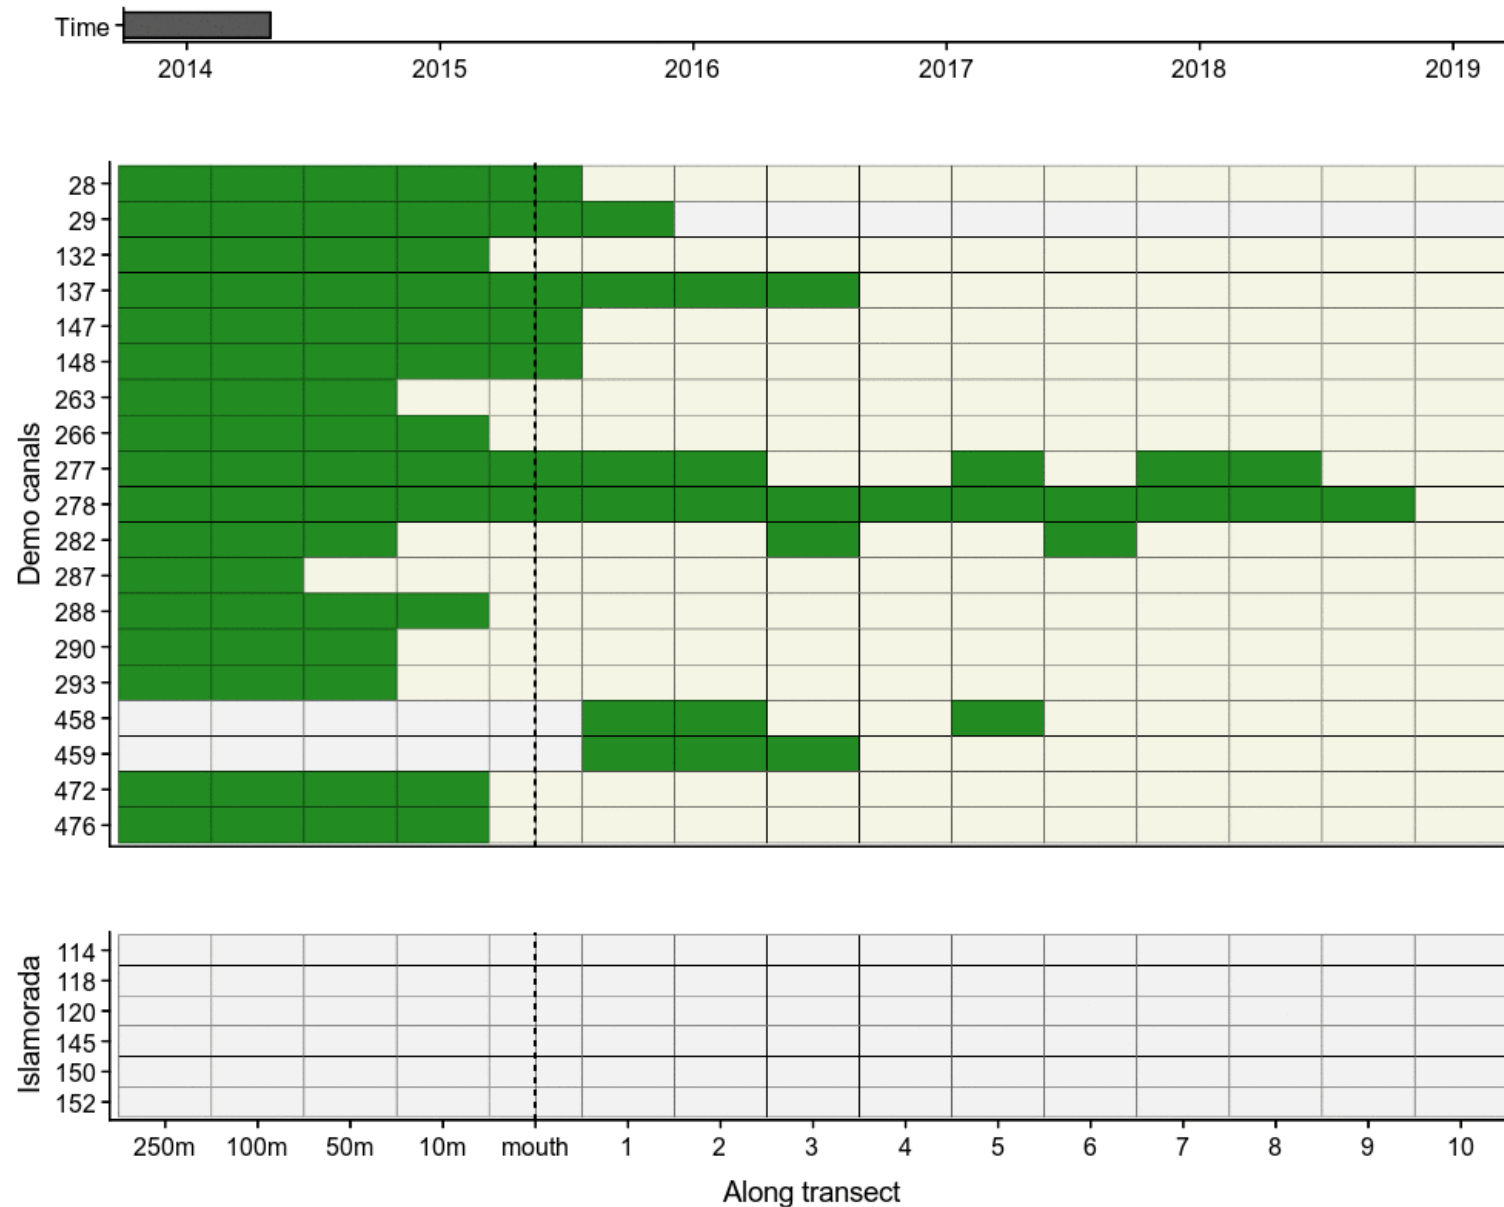
## Where plants are present

plants

Absent

Present

No Sample
