# Environmental Canal Restoration, Effects on Plants, Animals and Sediments

Jason Howard, Sara Wilson, James Fourqurean  
Marine Education And Research Initiative, Florida International University  
WGPP meeting, April 18

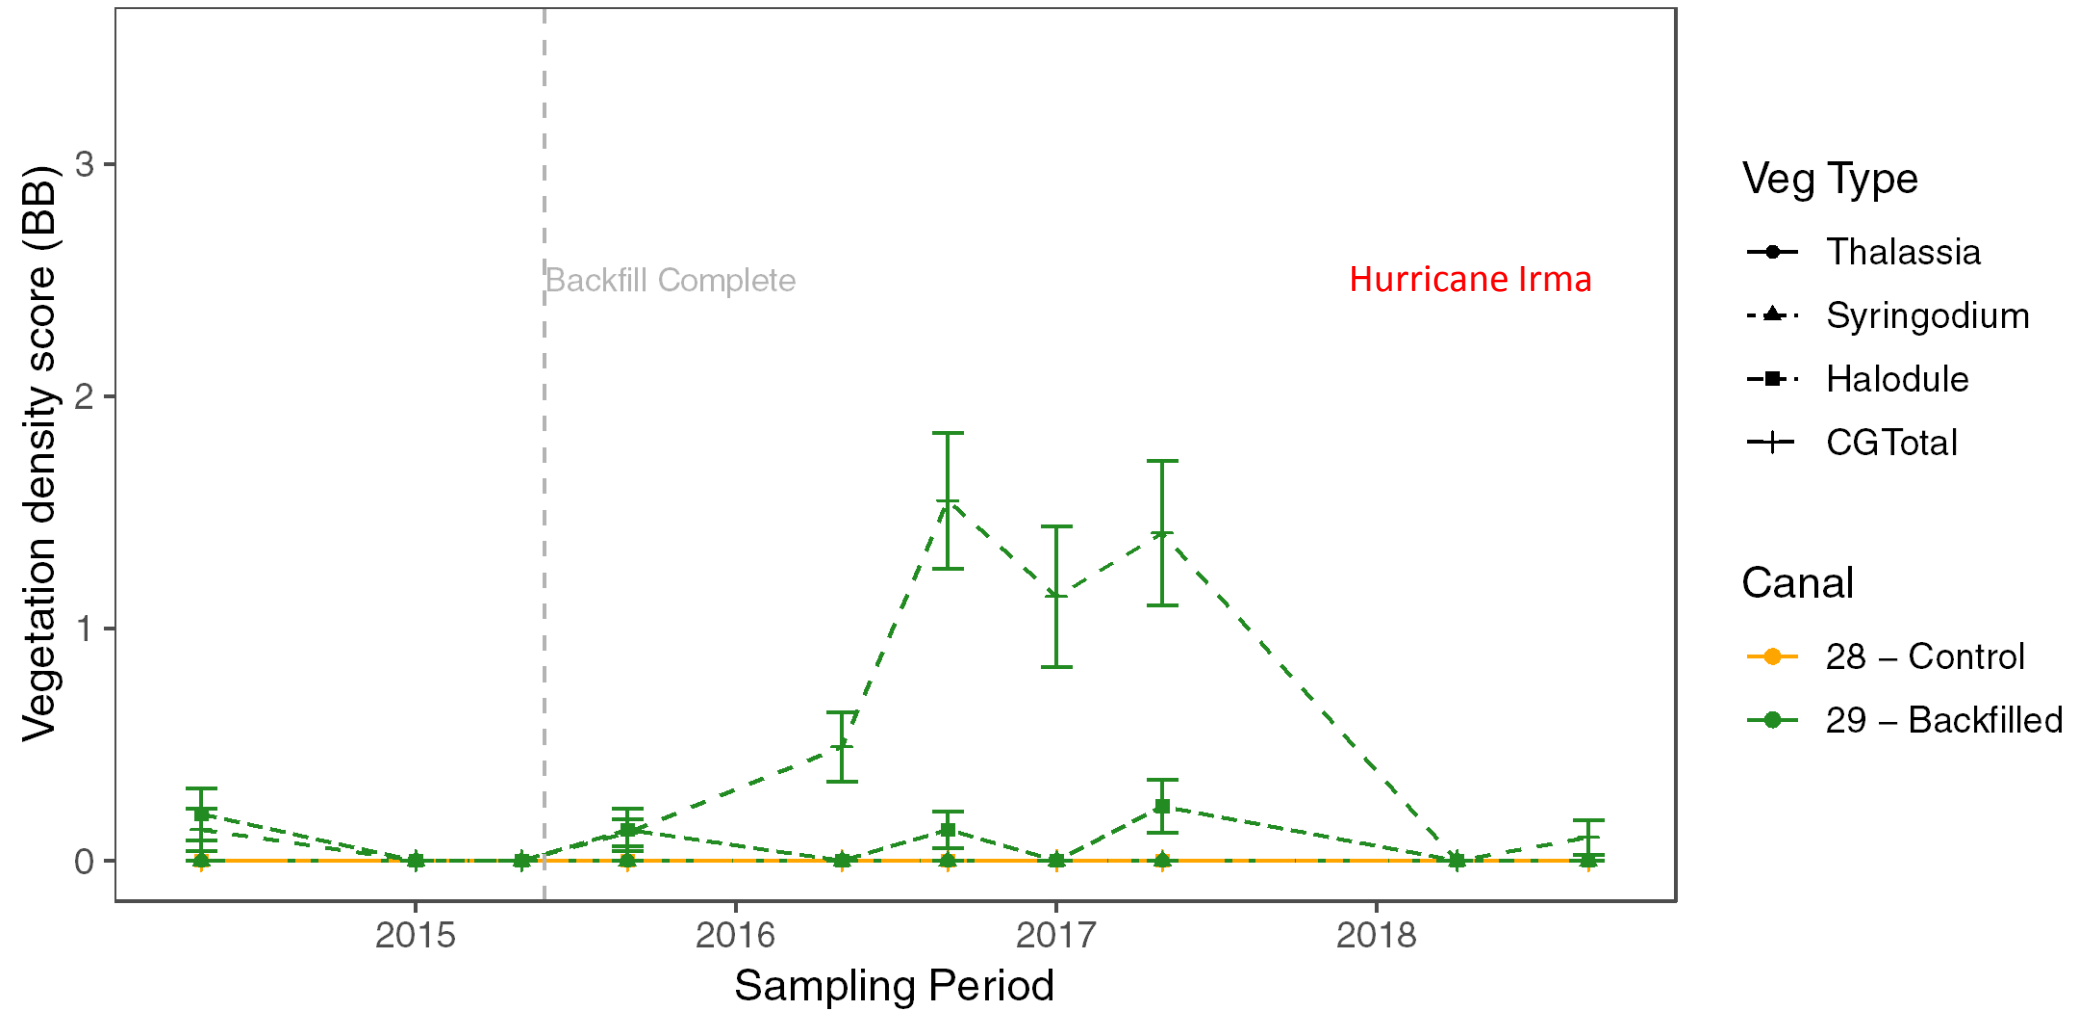
# Canal 29 – Vegetation Changes

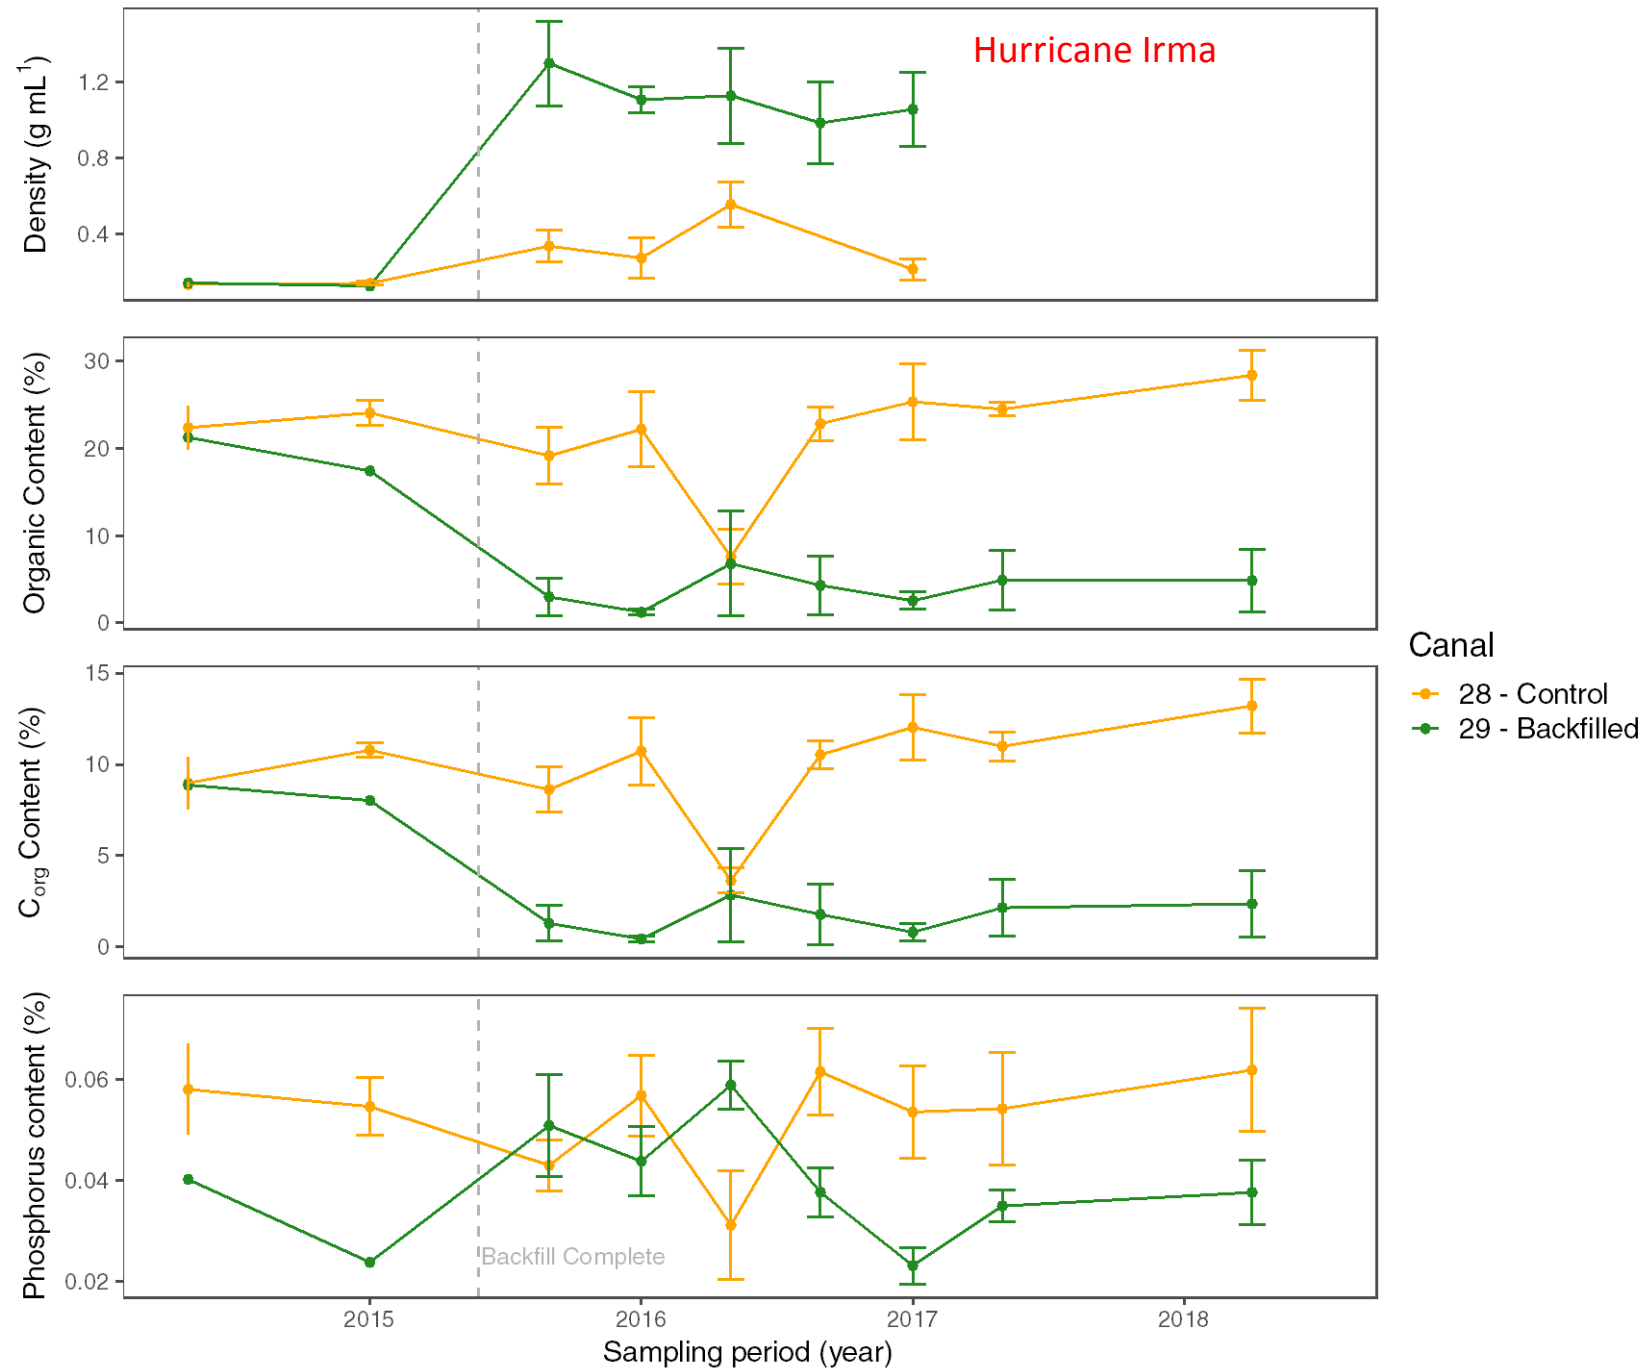
# Canal 29 – Sediment Change

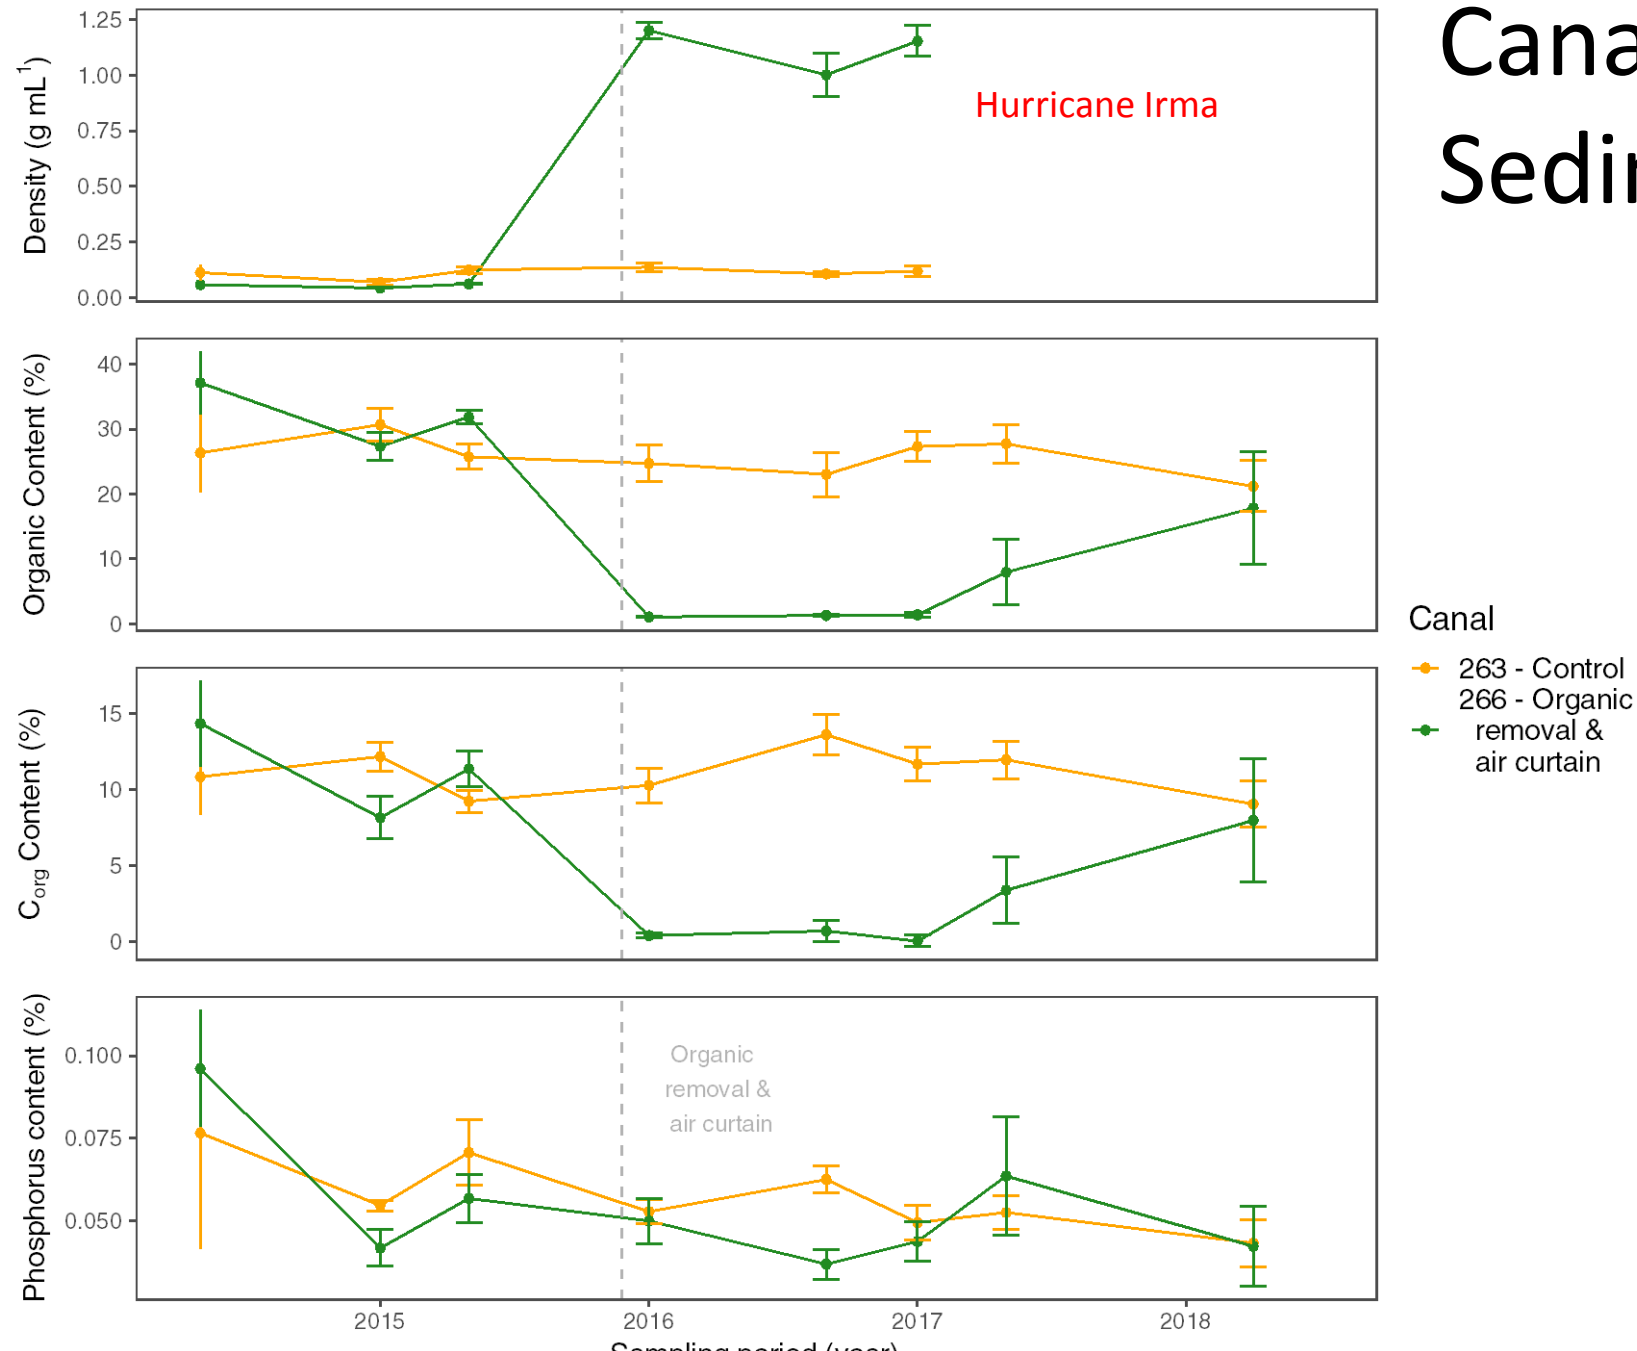
# Canal 226 – Sediment Changes

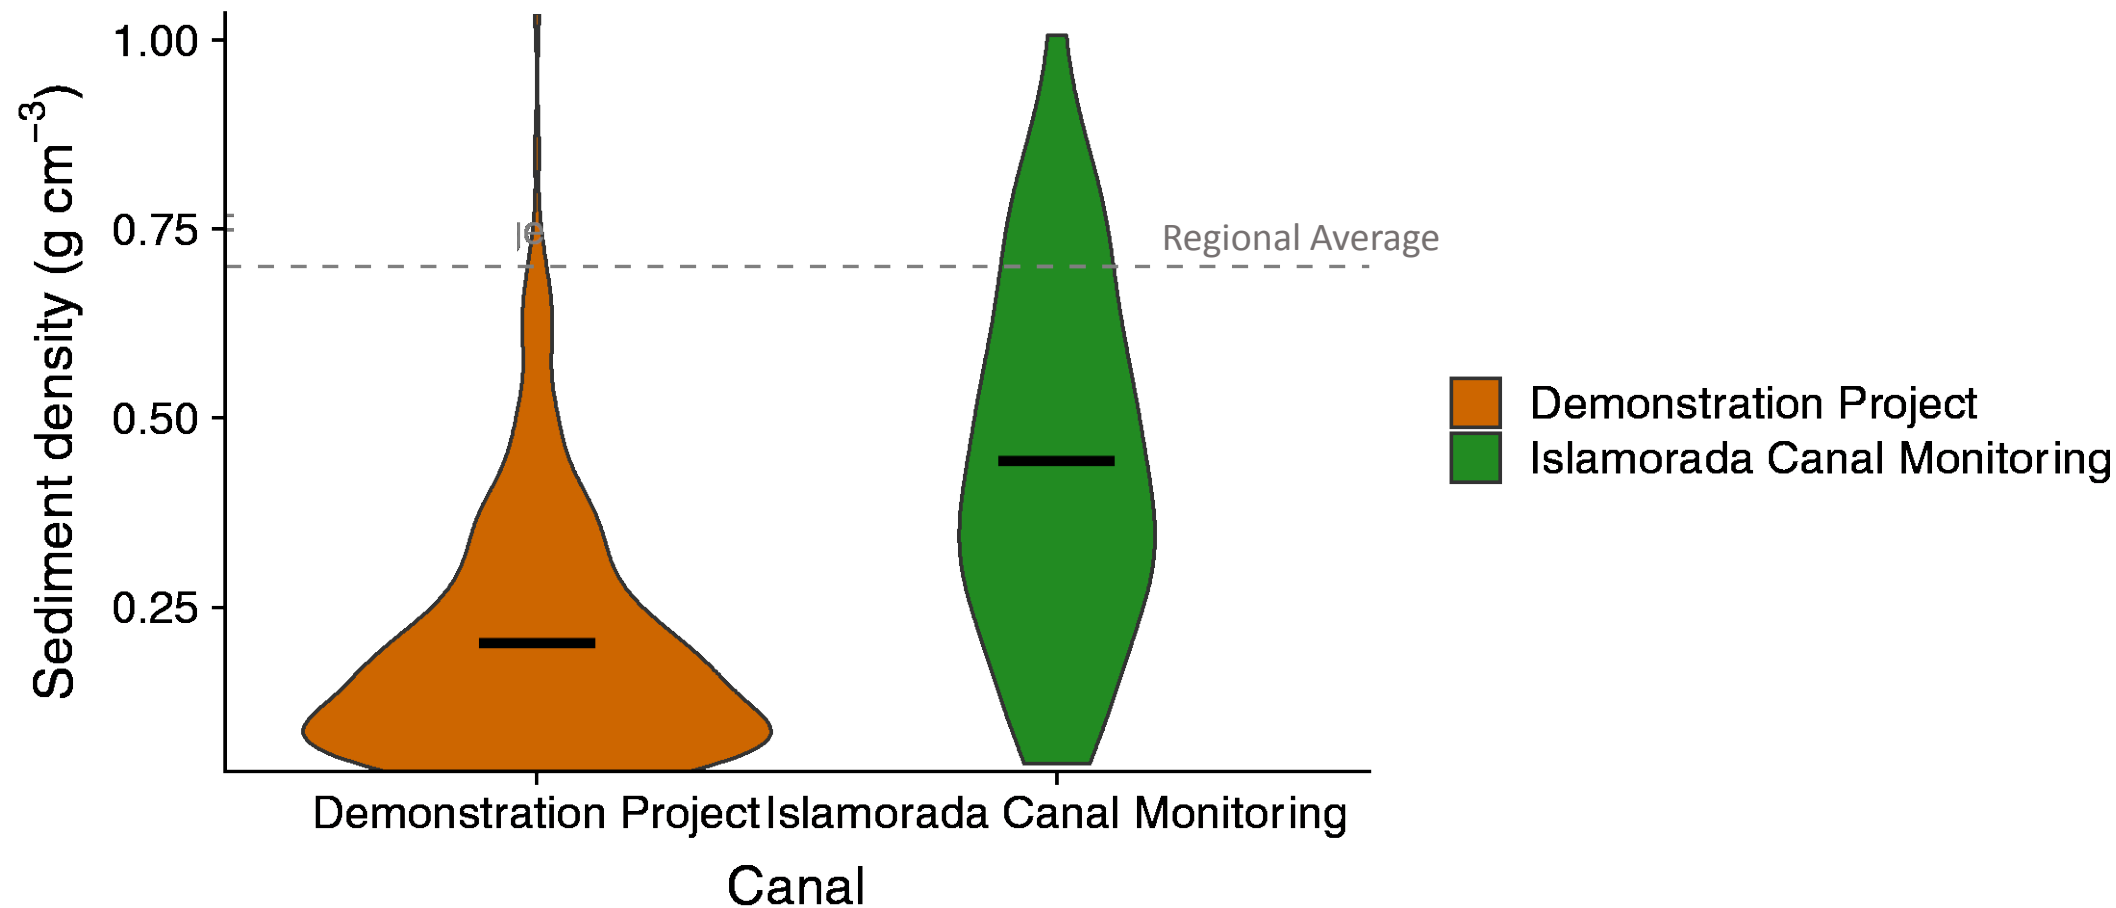
# Sediment Conditions between Projects
