Status of Residential Canal Benthic Habitats in the Florida Keys and the Effectiveness of Remediation Technologies Project Report

Prepared for the Water Quality Protection Program, Florida Keys National Marine Sanctuary
& The Village of Islamorada, Monroe County, Florida

Jason L. Howard, Sara S. Wilson, Christian C. Lopes, James W. Fourqurean

November 2018

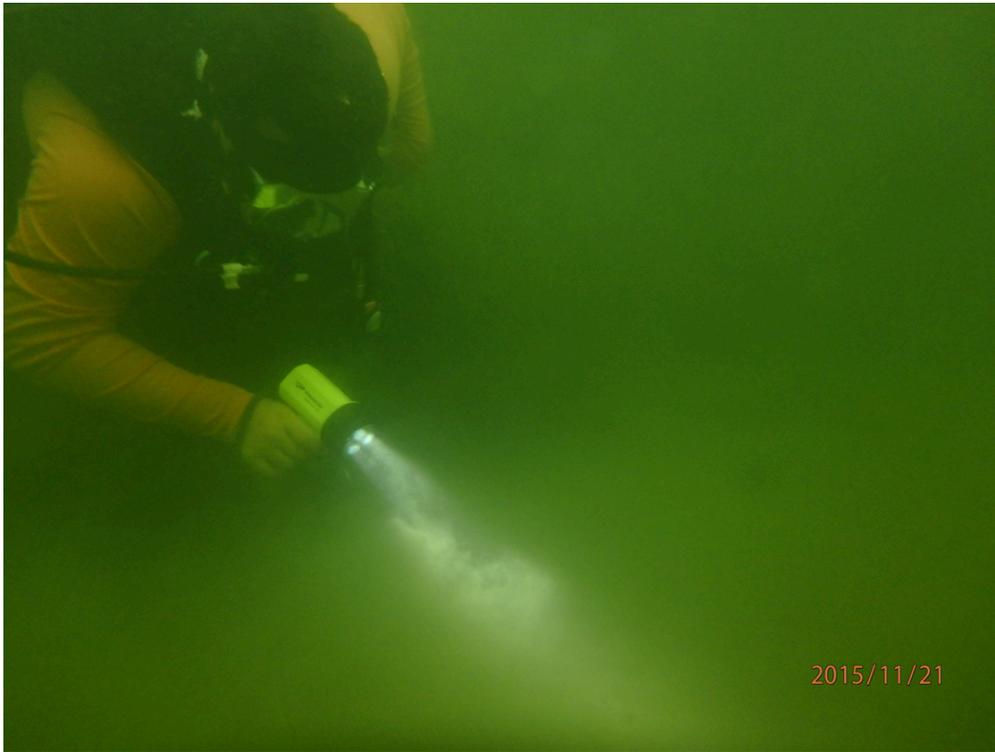
Seagrasses and other benthic vegetation require high light to grow. Monitored canals are visibly turbid with phytoplankton and organic material, sometimes with floating wrack blocking light entirely. The lack of seagrass and algae within the benthos and seawalls suggest insufficient light. Further, seagrass tissue $\delta^{13}\text{C}$ was consistently lower than the average values for natural waters in the FL Keys, suggesting a low photosynthetic rate (due to a lack of light) relative to the abundance of CO_2 in the environment (Fry et al. 1989).

Figure 4.1: Researchers are required to use underwater lights in some canals due to low light penetration. The cloudy, yellow water indicates sulfur metabolism and hydrogen sulfide resulting from a lack of oxygen.

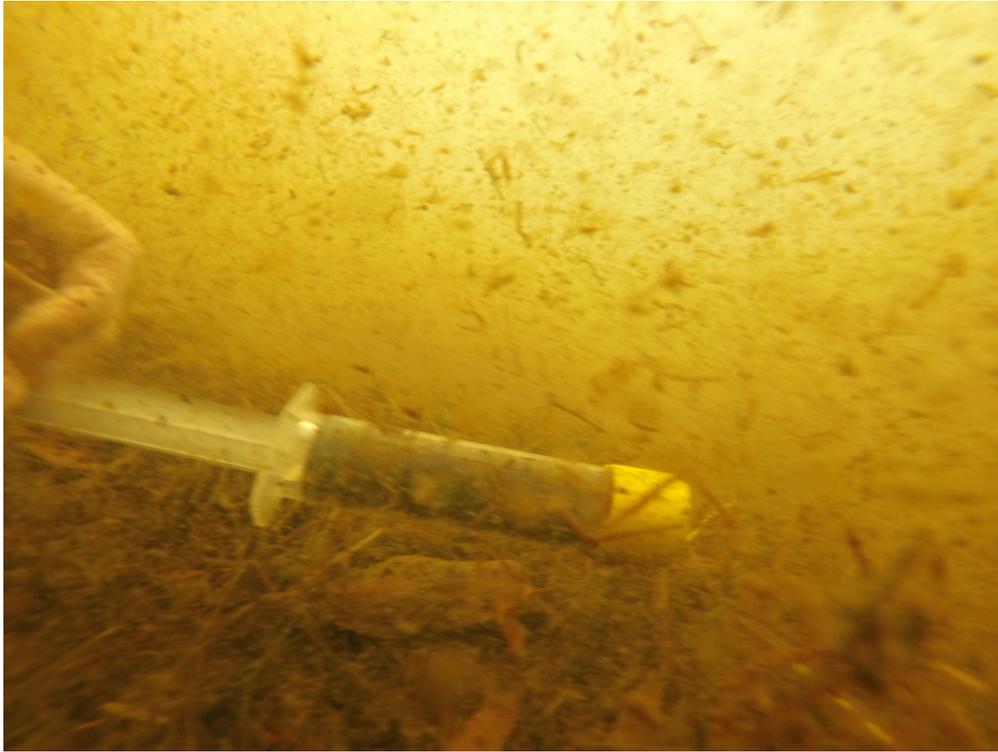
Benthic plants and animals require firm, stable sediments in which to take root. Average baseline measurements of sediment density were lower than those within South Florida seagrass meadows, and likely too low for anchorage of any seagrass species (Fourqurean et al. 2012a; Fourqurean et al. 2012b). Low-density sediments like those found in the canals are not compacted/firm enough to support plants and can easily be overturned, stirred up, or moved. Furthermore, the high organic content and the recognition of partially decayed wrack within canal sediments suggest that these sediments are actively decomposing. Decomposition in sediments consumes oxygen (required by benthic plants and animals) and produces hydrogen sulfide (a toxic gas) after oxygen is depleted.

Figure 4.2: Unstable, low-density sediments of impaired canals can easily be disturbed. Note the dead leaves and plant detritus that dominate surface sediments rather than expected sand grains. The pictured device was used to remove cores of surface sediment for laboratory analysis.

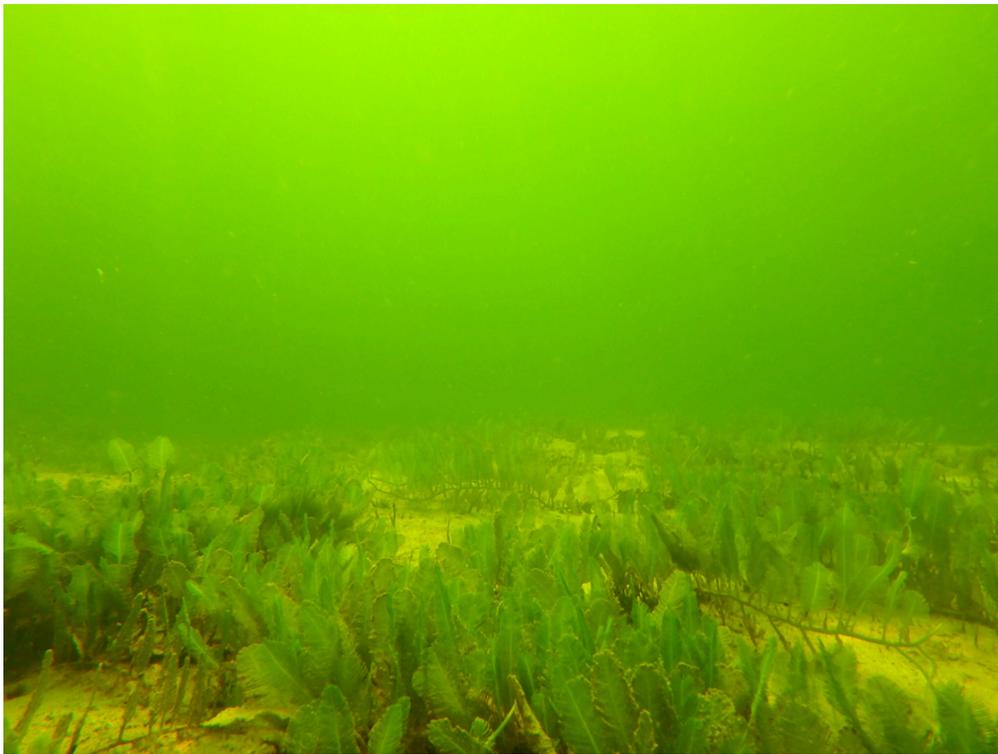
The backfilling of Canal 29 resulted in immediate improvements in sediment conditions and benthic vegetation. Sediment density was increased beyond the average value for FL Keys, making it suitable for plants to take root. Decomposing, organic-rich sediment was buried by the added carbonate fill, preventing it from further affecting water column oxygen and nutrient levels. The decreased water depth allowed light to penetrate to the sediment. As a result, there were measurable increases in benthic vegetation, fish diversity and abundance and inhabitants of the sea walls.

Figure 4.3: . Benthic algae taking root in newly backfilled sediment in Canal 29. Prior to backfilling, light did not penetrate more than 10 ft into the water.

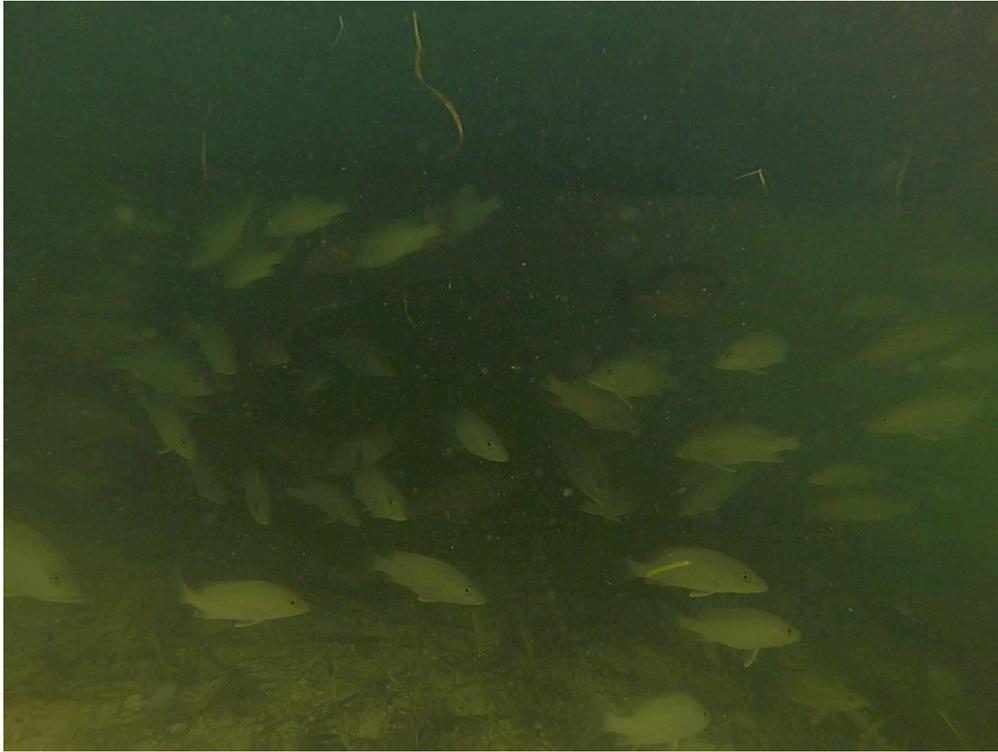
Figure 4.4: Dozens of Mangrove snapper observed in the rear of Canal 472 after the opening of the culvert.

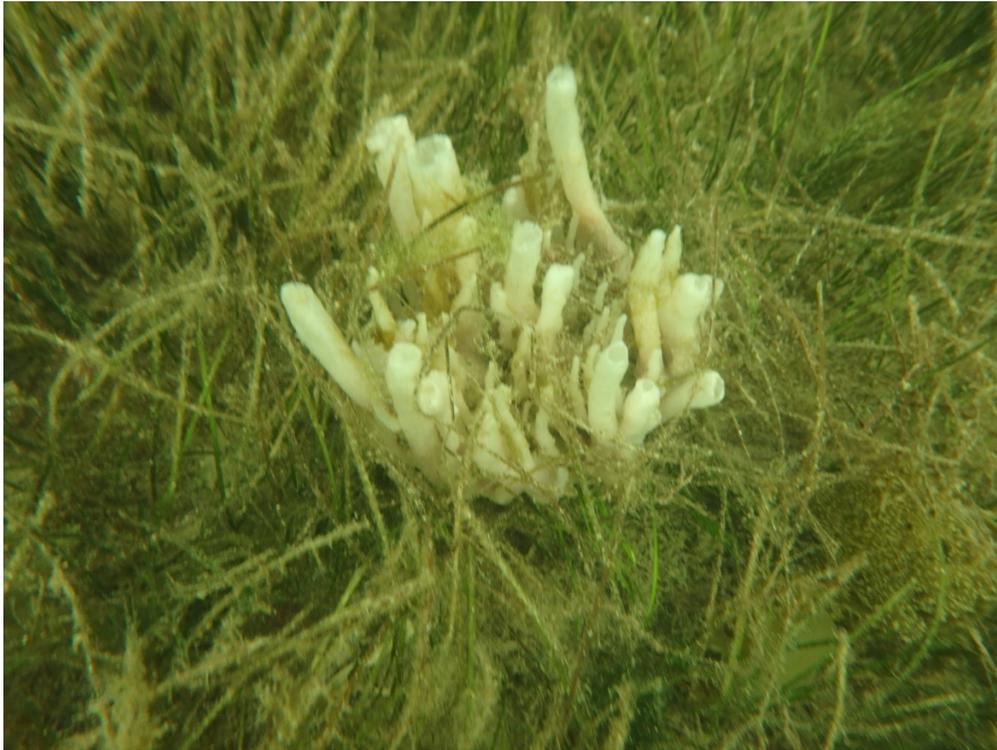
Figure 4.5: Sponge found in dense meadows of *Halodule wrightii* approximately a third into Canal 150. Benthic conditions in Canal 150 were consistently better compared to demonstration canals and other Islamorada project canals.
